PROPERTY INSPECTION REPORT

Property Address: 2 Paseo De Vaqueros
Salinas, CA

Date of Inspection: May 10, 2019

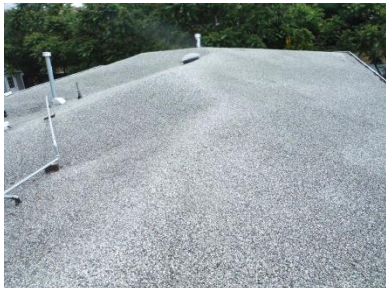
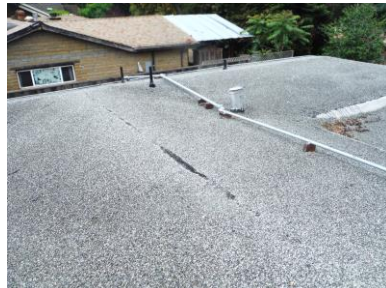
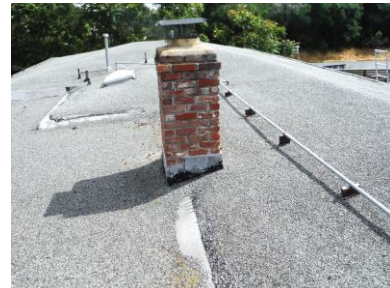
Roof Photos

There is exposed and cracked tar on various areas of the roof.

The roof jack flashing for the electric service mast is not sealed.

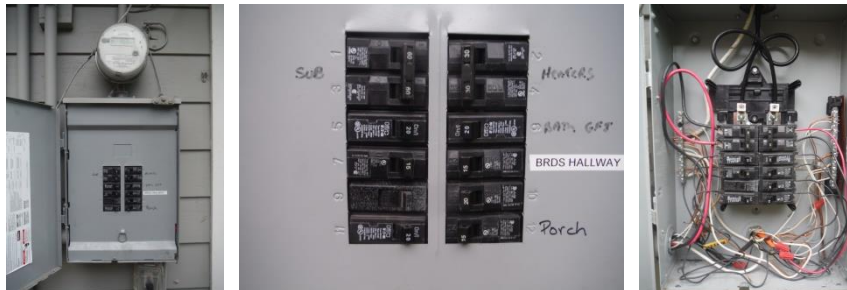
The clearance of the service drop conductors (the wires from the utility to the residence) above the ground is less than the minimum allowed per current construction standards (12 feet above pedestrian areas).

The insulator for the main neutral conductor attached to the service mast is not secured.

There is no main disconnect breaker installed in the main service panel.

Main Service Panel Location: At the left front side of the residence as shown in the photos below.
