American Inspection Service

Property Inspection Report

Torres 2 S.E. of 9th, Carmel By the Sea, CA, 93923

Date of Inspection: 1/8/2021

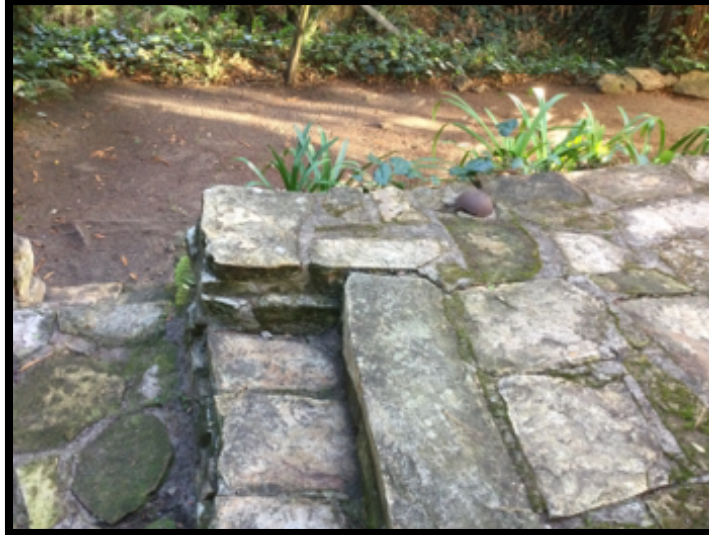
1. Property Observations

- There are areas of this property that do not have guardrails. Therefore, children should be monitored if the visit or occupy the residence. Common safety standards require them to be a minimum of four inches high when the standing surface is thirty inches or more above grade. Also, guardrail pickets should be no more than four inches apart for child safety.

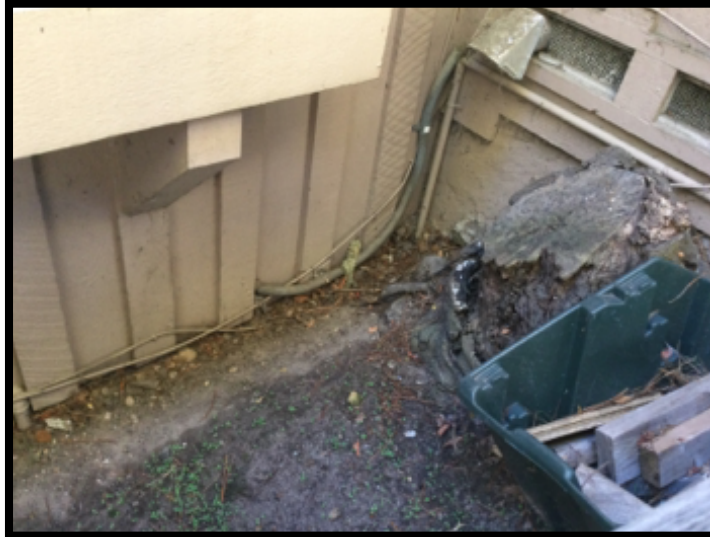
3. Drainage Mode

- Drainage is facilitated by soil percolation hard surfaces, area drains, and full or partial gutters. However, the area drains must be kept clean or moisture intrusion could result.
- Grading and drainage is either negative or neutral adjacent to the residence, and moisture intrusion will remain a possibility. The soil or the hard surfaces should slope away from the residence to keep moisture away from the footings. We can elaborate on this issue, but we recommend you seek a second opinion from a licensed landscape contractor who could make suggestions on possibly re directing the soils.

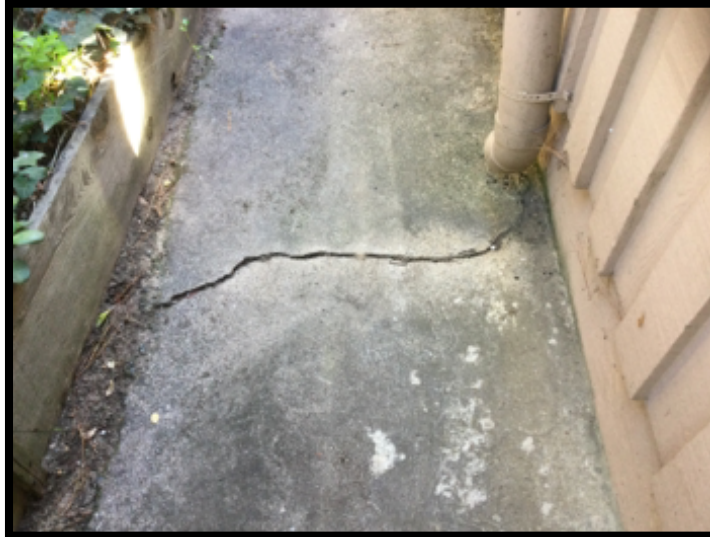
7. Walkway Conditions

- There is an offset in a walkway that could prove to be a trip hazard and you may wish to have it evaluated.

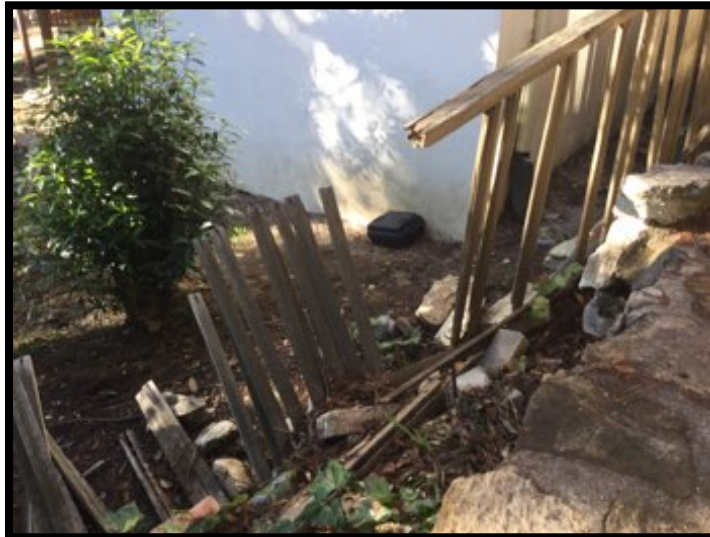
8. Fences and Gates

- Sections of the fence are leaning or damaged and should be repaired or replaced.

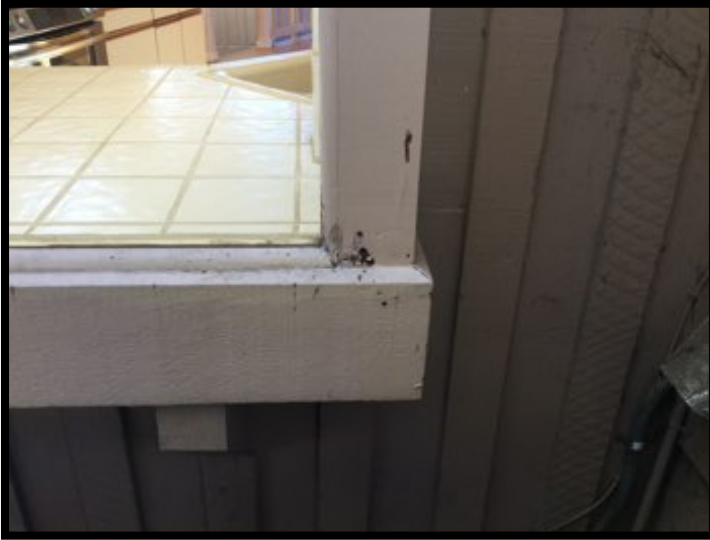
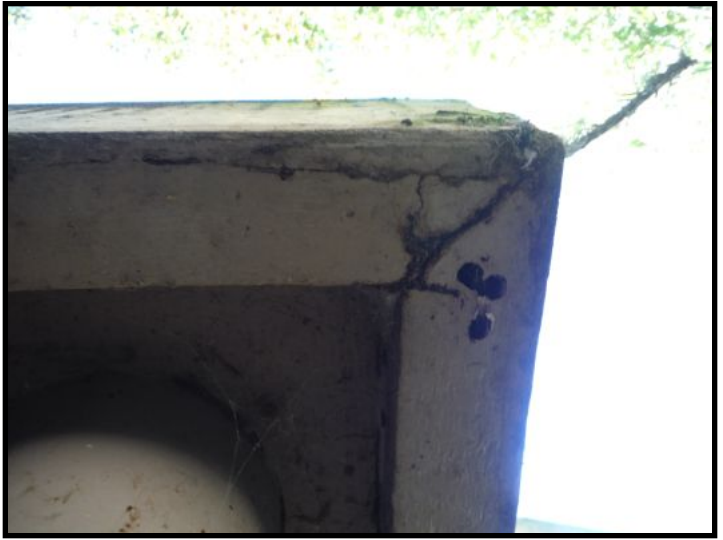
9. Facia and Trim

- There is insect or moisture damage to portions of the wood trim that should be evaluated by a termite inspector or licensed contractor.

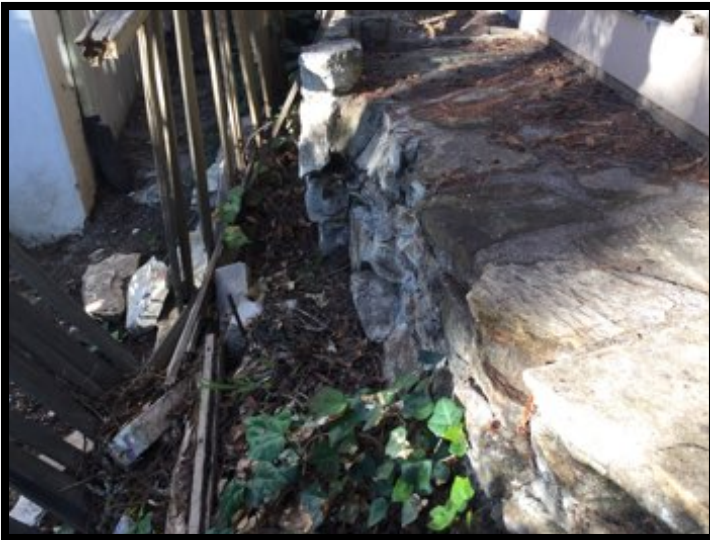
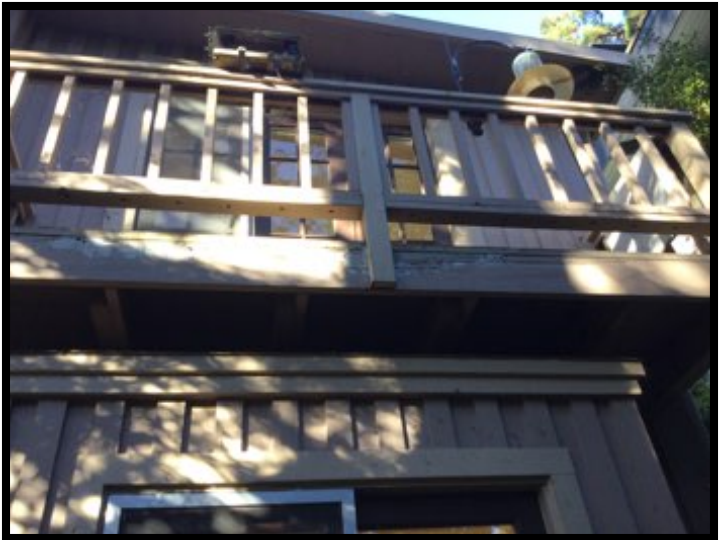
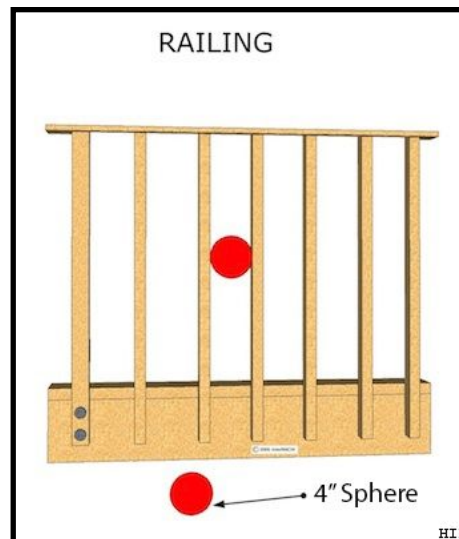
11. Wood and Masonry Decks

- There is damage to the wood deck that should be evaluated by the termite inspector or licensed contractor.
- The deck rail balustrades exceeds 4", which is today's standard. Recommend decreasing the space between the balustrades to 4" especially if young children or small pets occupy the residence.
- The rear stone deck is deteriorated and should be serviced.

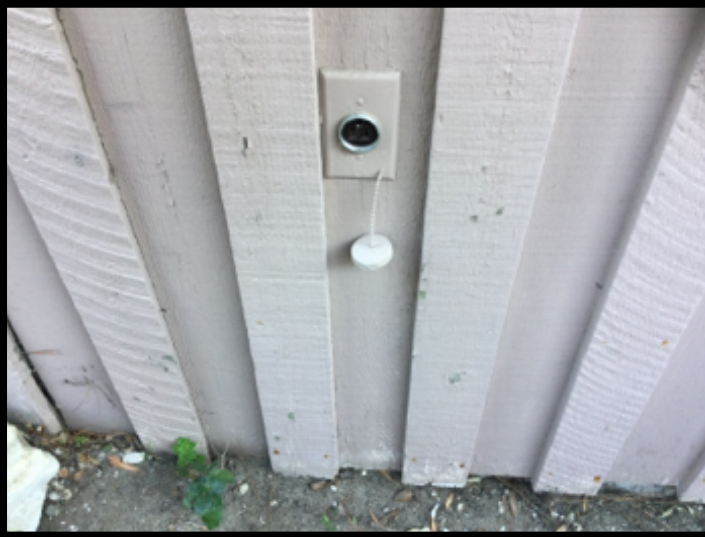
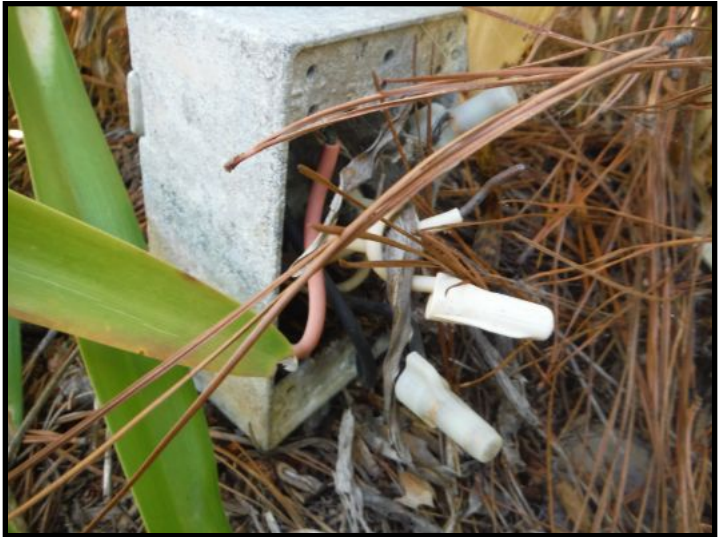
13. Outlets

- The outlets that were tested are functional and include ground fault protection. • An outlet is not energized. Recommend a licensed electrician evaluate the outlets.
- There is an open junction box in the side yard that should be sealed. Recommend a licensed electrician evaluate.

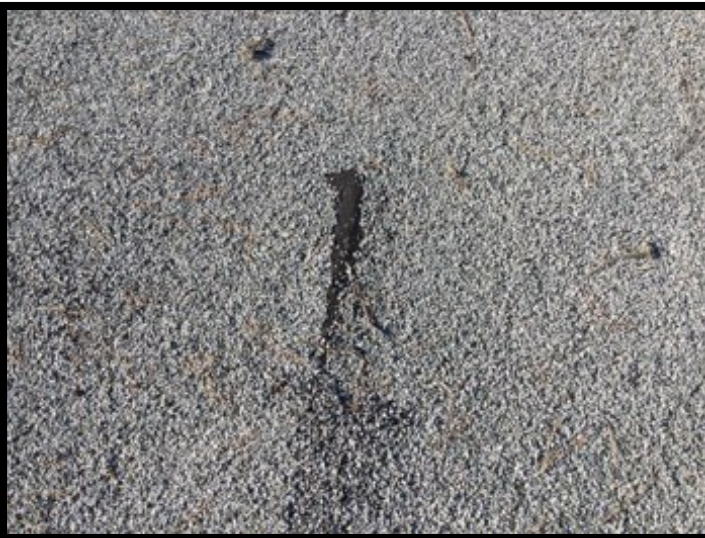
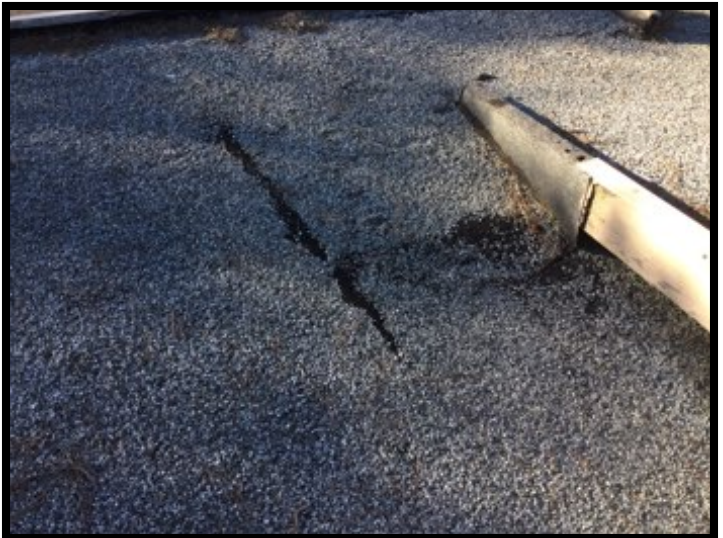
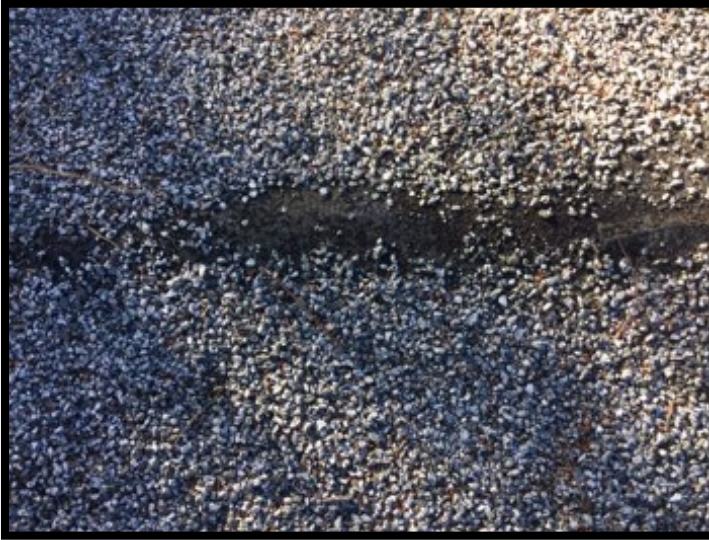
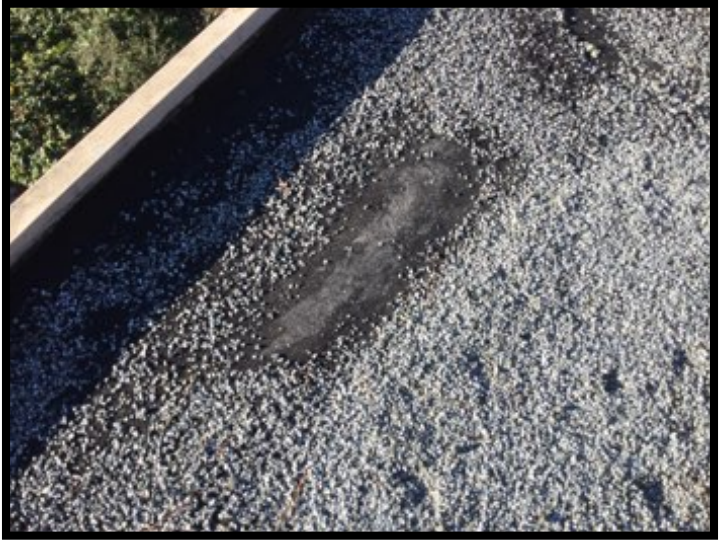
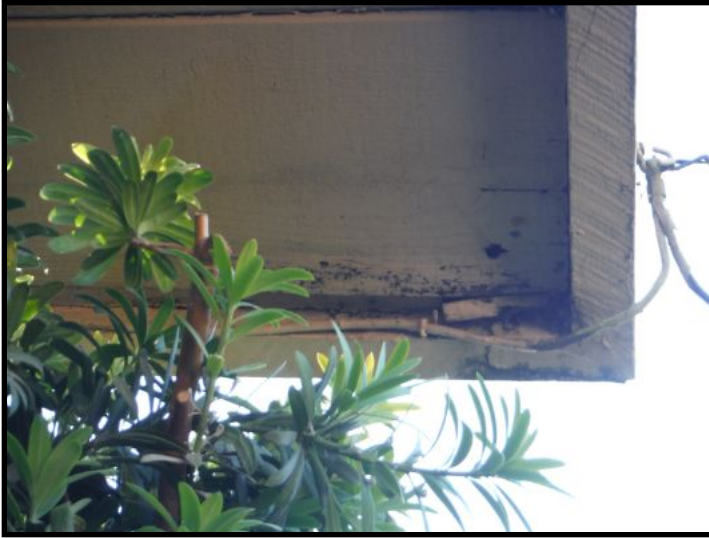
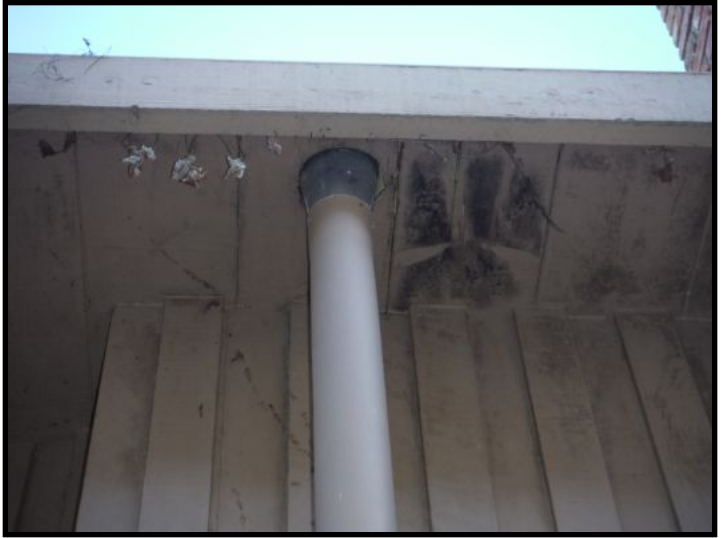
3. Roofing Material

The tar and gravel roof has multiple bare spots that should be serviced to prevent the membrane from deteriorating. Recommend a licensed roofing contractor evaluate.

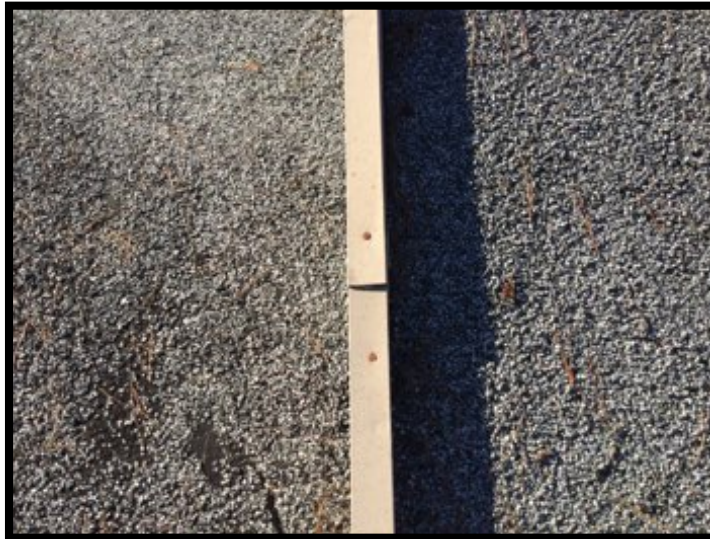
4. Flashing's

- The roof flashing's need to be sealed or serviced. They are comprised of metal that seals **valley's** and vents and other roof penetrations, and are the most common point of leaks. This is particularly true of the flashing's on a layered roof, which are covered by the roofing material and which are even more susceptible to leaks.
- The exposed nails on the flashing's should be sealed to prevent moisture intrusion. Recommend further evaluation by a licensed roofing contractor.

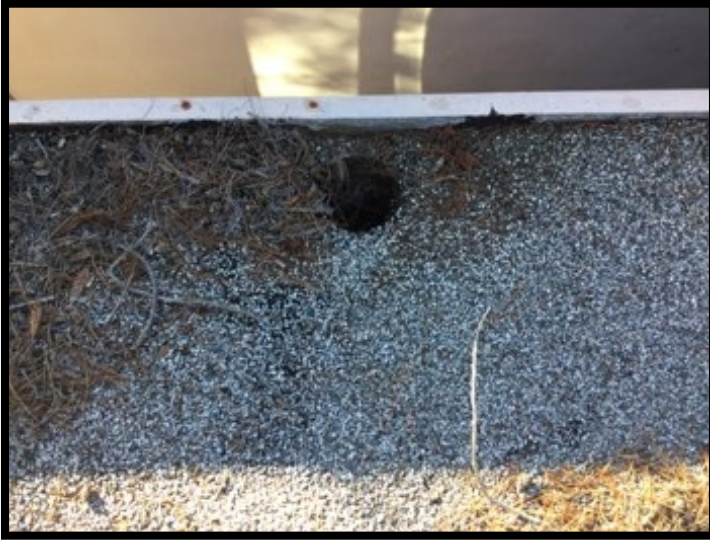
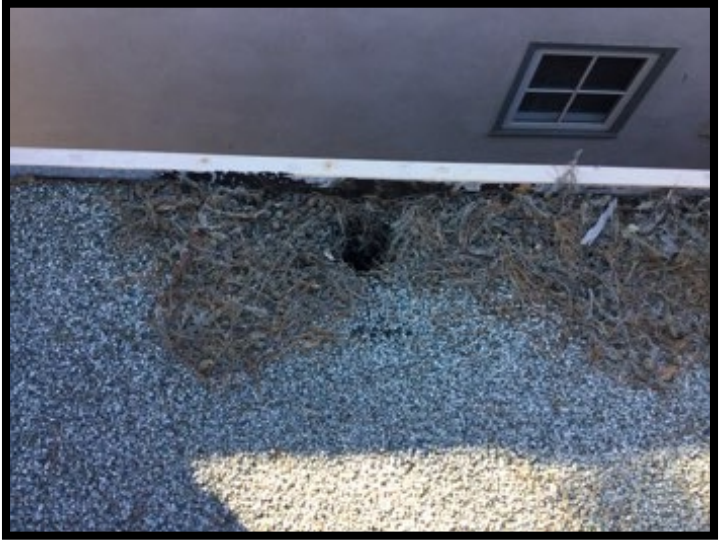
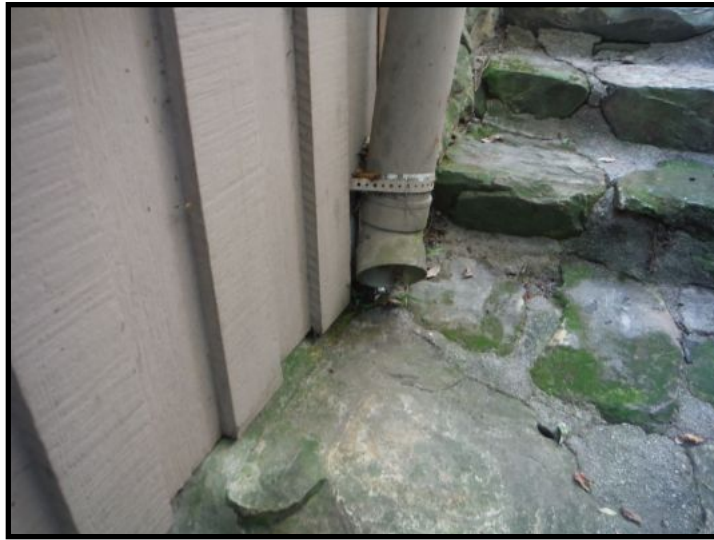
6. Gutters and Drainage

Page 14 Item: 6	Gutters and Drainage	<ul style="list-style-type: none"> • The roof has a gutter less drainage system that employs down spouts in the eaves, but no gutters. Water runs down the roof to a raised dam along the leading edges where it is supposed to turn and run sideways until it reaches a point in the eaves, where it discharges into a downspout. However, level planes rarely exist on houses, and instead of performing as it is intended the water invariably ponds along the edges and deteriorates the roof and its eaves, which has already happened. The termite inspector will comment on this, but you should also consult a roofing contractor about modifying this ineffectual and problematic drainage system. • It would be prudent to add leaders and/or splash blocks at the bottom of the down spouts to promote positive drainage and divert water away from the perimeter footings.
Plumbing

- The roof has a gutter less drainage system that employs down spouts in the eaves, but no gutters. Water runs down the roof to a raised dam along the leading edges where it is supposed to turn and run sideways until it reaches a point in the eaves, where it discharges into a downspout. However, level planes rarely exist on houses, and instead of performing as it is intended the water invariably ponds along the edges and deteriorates the roof and its eaves, which has already happened. The termite inspector will comment on this, but you should also consult a roofing contractor about modifying this ineffectual and problematic drainage system.
- It would be prudent to add leaders and/or splash blocks at the bottom of the down spouts to promote positive drainage and divert water away from the perimeter footings.

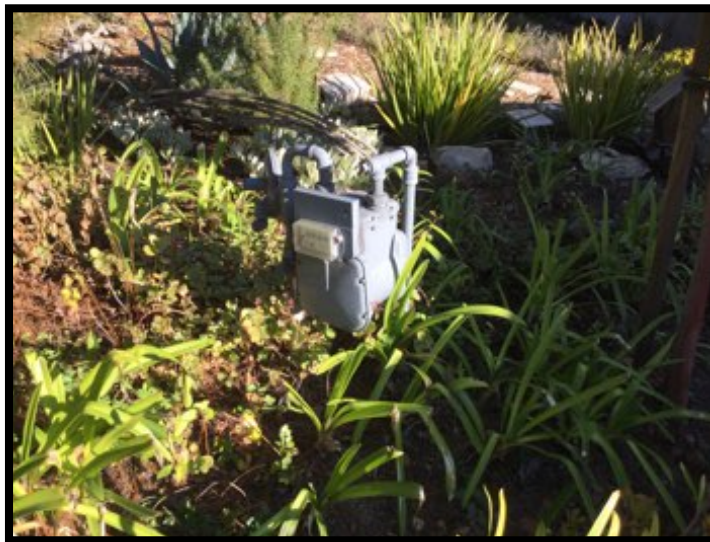
3. Gas Main Location

- The gas main is located in the side yard.
- There is no wrench at the gas shut off valve to facilitate an emergency shut off, and inasmuch as such tools are relatively inexpensive we recommend that you buy one and leave it in place on the valve.

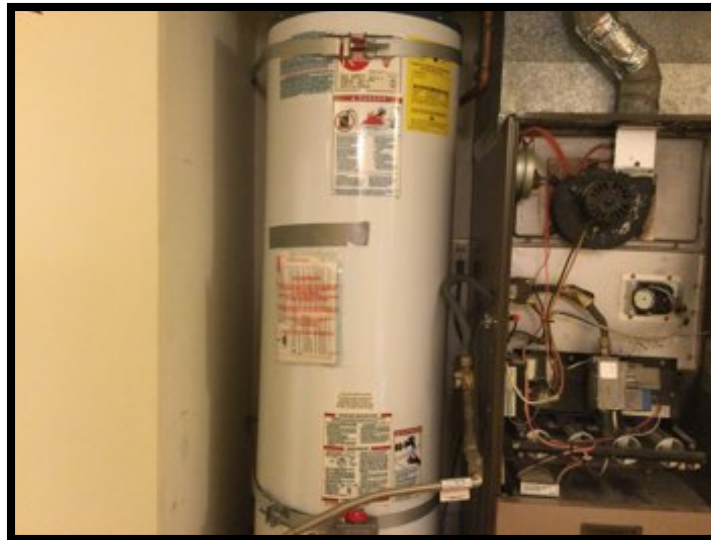
1. Age Capacity and Location

- Hot water is provided by a 23 year old, 40 gallon water heater located in a downstairs closet.
- The water heater is beyond it's commonly expected design life and should be closely monitored for any signs of leaks.

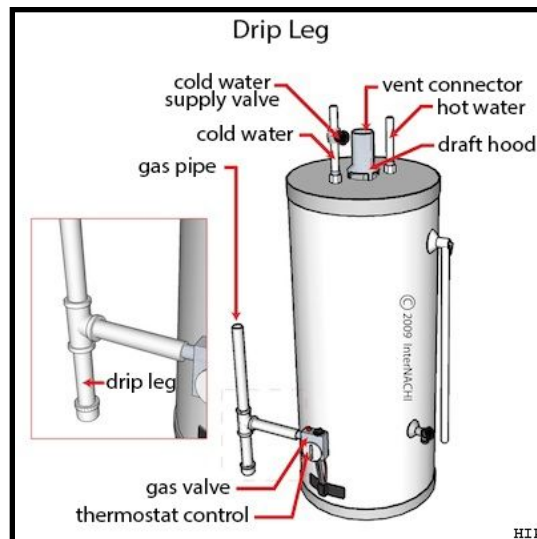
4. Gas Valve

- The gas control valve and its connector at the water heater are functional.
- The gas valve does not include a sediment trap or drip leg, and we recommend one be installed by a licensed plumber to prevent debris clogging the gas orifice.

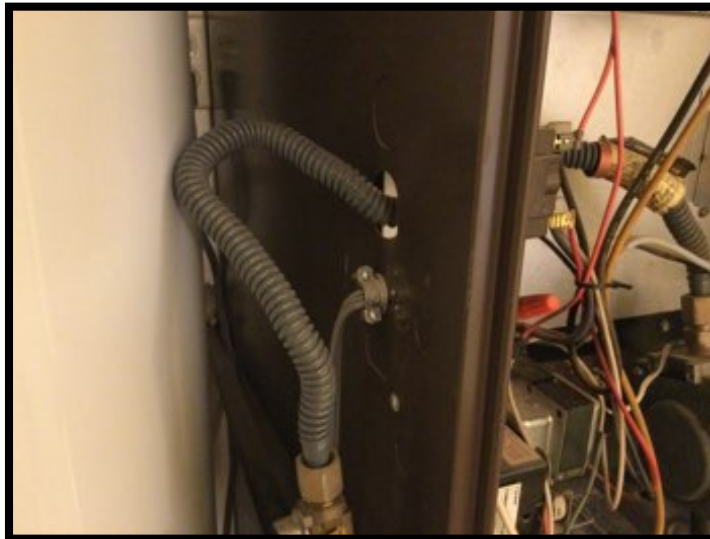
5. Gas Valve and Connector

- You should be aware that the gas feed line that pass through the furnace sidewall is flexible, and are required by current codes to be rigid until it passes beyond the furnace, and then flexible to the point where it connects to the valve. This condition should be corrected by an HVAC contractor.

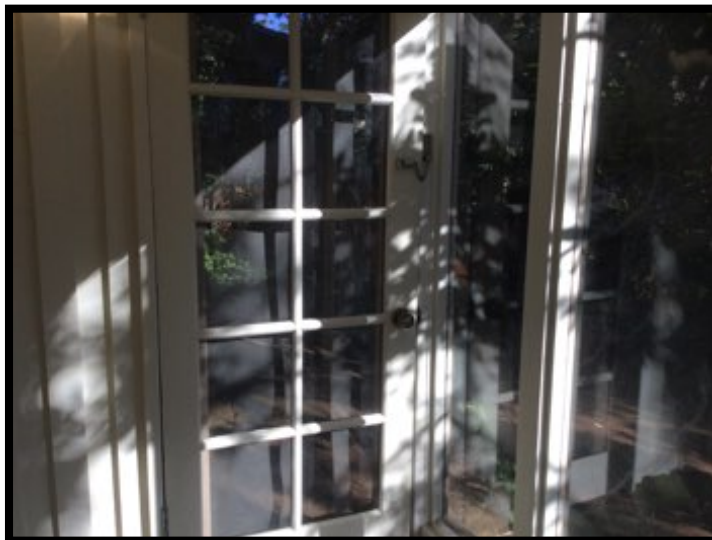
1. Doors

- The door rubs, and needs to be serviced to work smoothly.

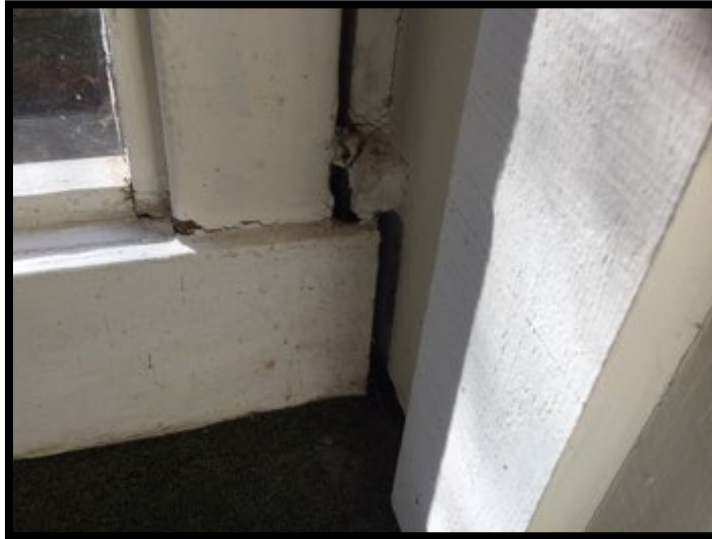
2. Floors

- The floor is out of level and the room is pulling away from the main structure. Recommend further evaluation by a licensed contractor.

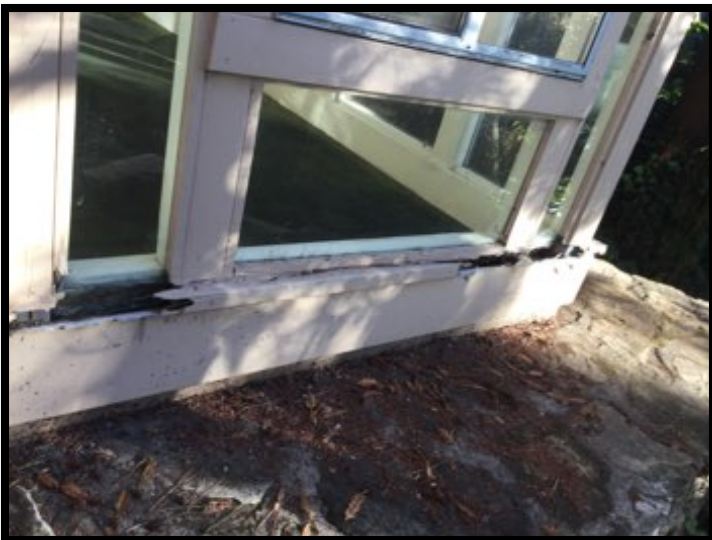
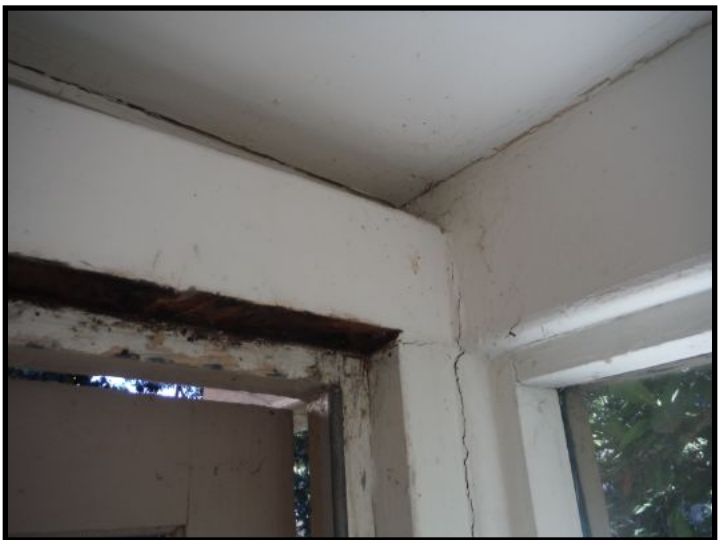
3. Walls and Ceiling

- There is evidence of moisture intrusion that should be evaluated by a licensed contractor or termite inspector.

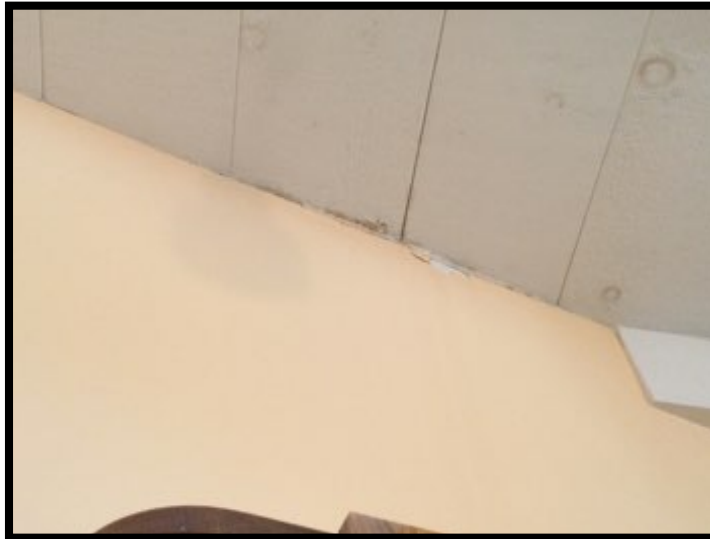
2. Walls and Ceiling

- There is a moisture stain on the ceiling, which you should ask the sellers to explain or have explored further.

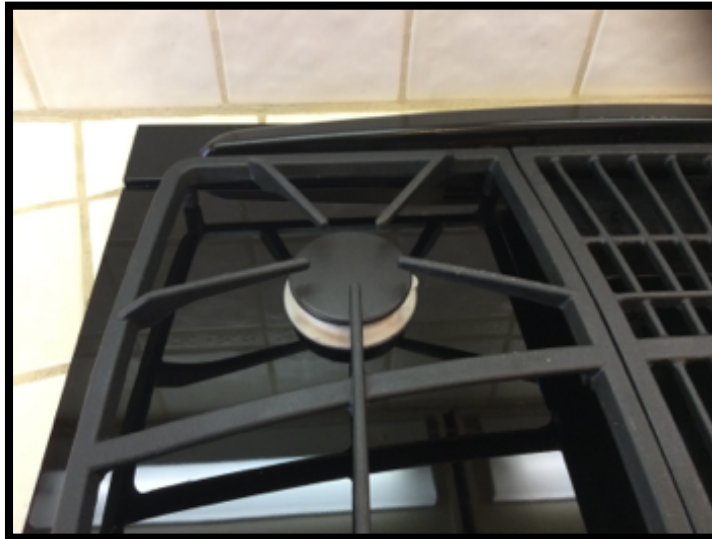
10. Gas Cook Top

- One or more of the gas cook top burners did not respond and should be serviced by a qualified technician.

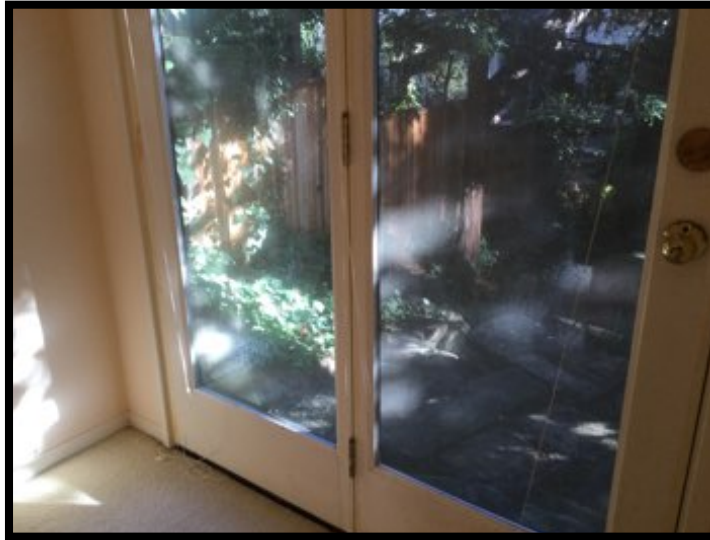
1. Doors

- There is a broken hermetic seal or seals in the door window panel or panels, which has allowed condensation to form between the window panes which should be replaced.

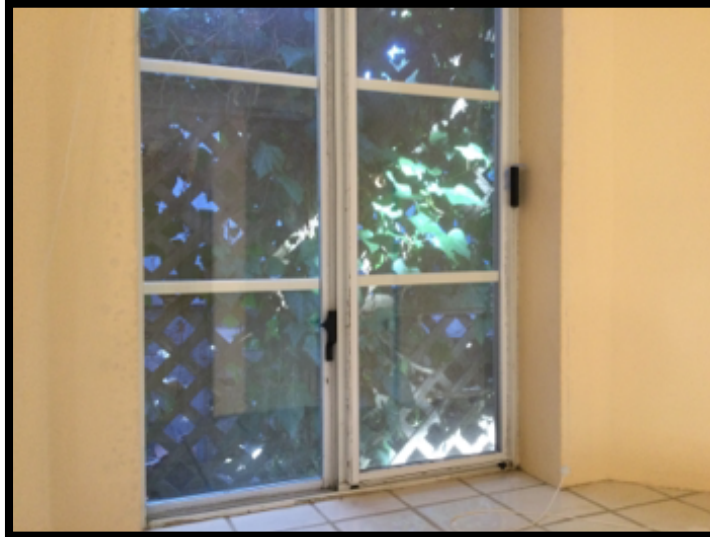
4. Dual Pane Windows

- A window or windows are stuck, painted shut, or will need service to work well, such as sanding, shaving, trimming, or servicing the hardware.

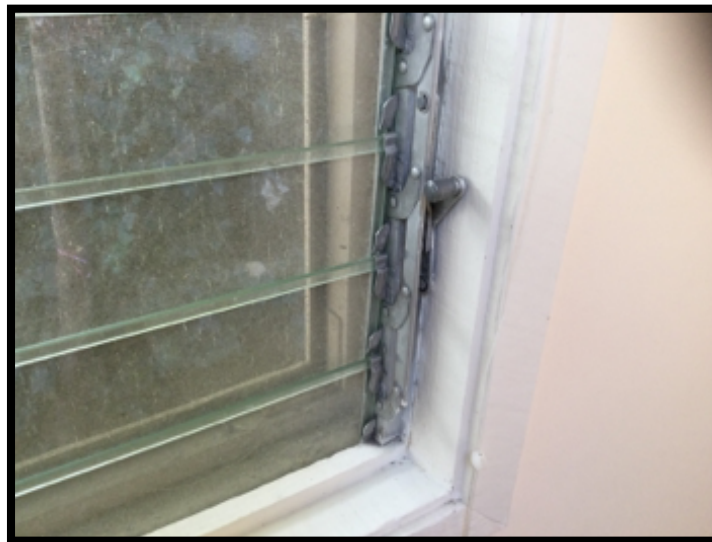
4. Single Pane Windows

- The window does not appear to be the correct size or location to permit escape in case of a fire. Therefore, you may wish to have a licensed contractor evaluate.
- A window or windows are stuck, painted shut, or will need service to work well, such as sanding, shaving, trimming, or servicing the hardware.

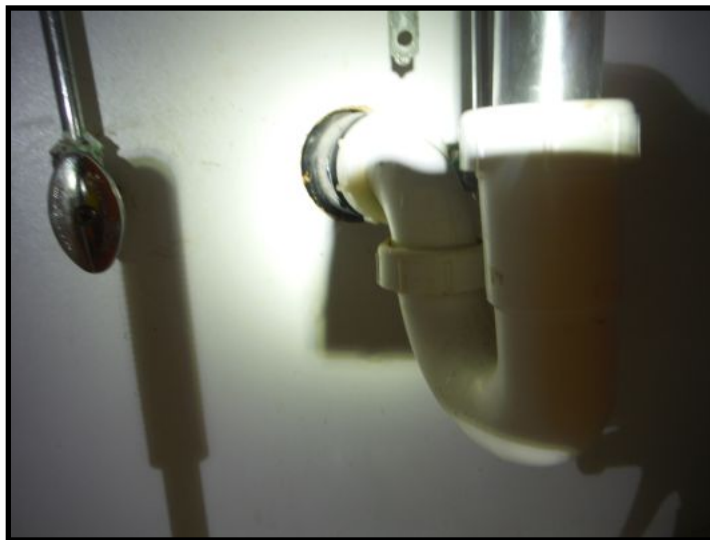
6. Sinks and Related Components

- There is a leak at the drain trap below the sink, which should be repaired.

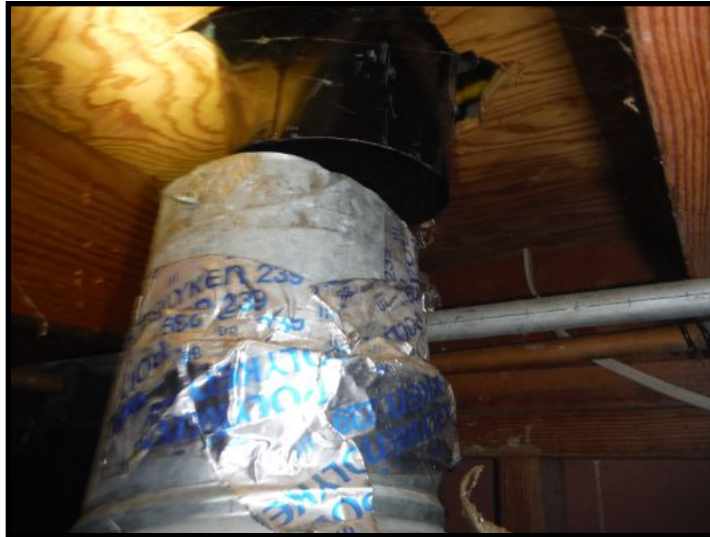
2. Dryer Vent

- The dryer vent is separated within the sub area and should be repaired.

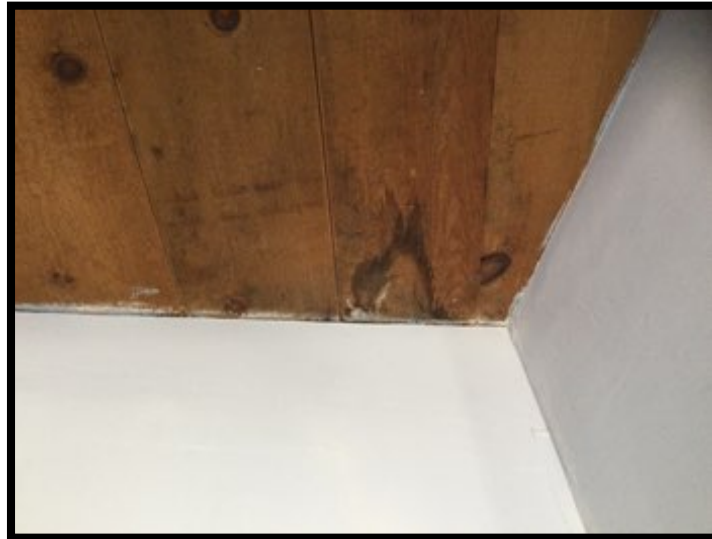
2. Walls and Ceiling

- There is a moisture stain on the garage ceiling, the cause of which should be explained or explored further. However, we not unable to confirm that is being caused by an active leak.

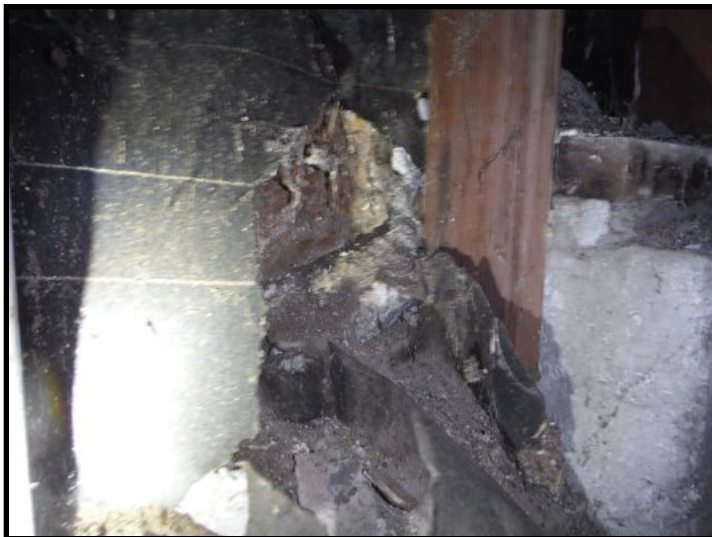
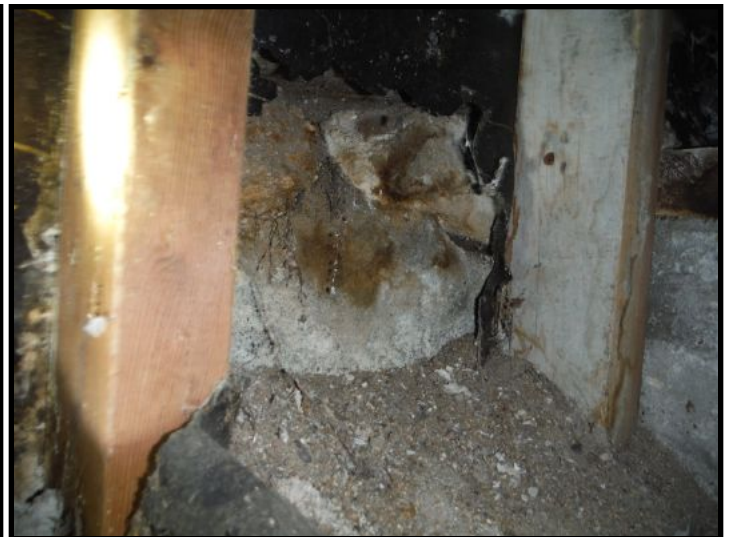
5. Intermediate Floor Framing

- There is earth to wood contact noted at several locations in the crawlspace. Earth to wood can allow moisture and insect intrusion to attack the framing members. Recommend further evaluation by a licensed termite inspector prior to the close of escrow

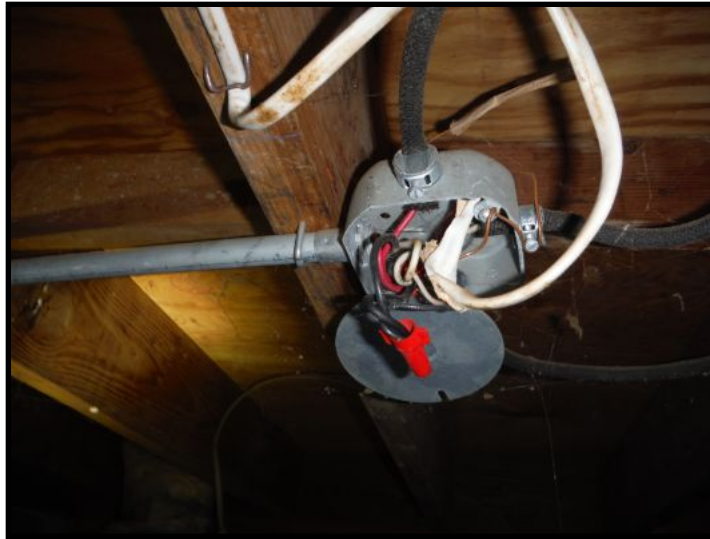
6. Electrical

- There is an open electrical junction box within the crawlspace, which should be sealed so that any arcing or sparking would be contained within the box.
