State of the Chimneys

Morrill & Forbes Chimney Sweeps & Fireplaces, Inc.

Escrow Report #3407122 Re: Torres 2 SE of 9th, Carmel, CA on 1/8/21

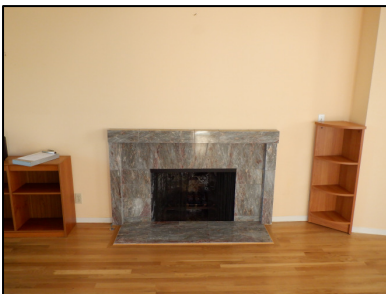
PHOTO #1

Inspection of the firebox area at the above address revealed that the hearth and facing is constructed with stone tile with spark screens installed for the firebox opening that are slightly stiff to operate. There is a gas kindler valve installed in the floor to the left hand side, inspected for gas leaks, none found at time of inspection. The hearth for this fireplace measures 18" to the front and today's NFPA 211 standards state that hearths should be at least 20" to the front, this is an existing non-conforming condition, **see photo #1** showing firebox area with arrow indicating kindler valve.

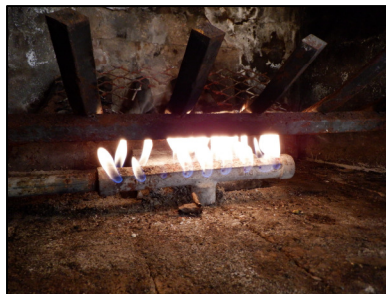
PHOTO #2

Inspection of the interior firebox revealed that there is a gas log lighter installed that operated with lit, **see photo #2** showing log lighter burning. There is a brick closing off the ash dump area and there is typically an ash dump door installed, **see photo #3** with arrow indicating brick. There is a great deal of efflorescence present in the firebox, indicating water intruding at some point, **see photo #4** showing white efflorescence staining. The firebox back had repairs performed at some point that is deteriorating and typically has a heat shield installed to protect the mortared area, **see photo #5** deteriorated repair. Inspection of the smoke chamber revealed that these areas needed cleaning and were not cleaned at time of inspection, **see photo #6** showing smoke chamber and lower flue. There is a rooftop damper installed that is operated by handle mounted on the firebox side, **see photo #7** with arrow indicating damper handle. It was noted that the firebox is very moist and has a strong musty odor indicating moisture intruding for some time.

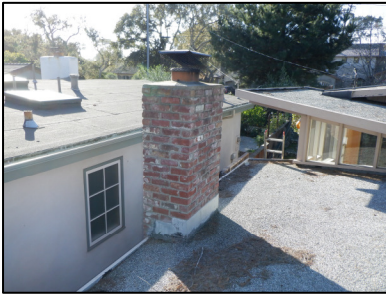
PHOTO #11

Inspection of the chimney above the roofline revealed that the chimney is of satisfactory height and the flashing appeared to be in satisfactory condition at time of inspection, **see photo #11** showing chimney above the roofline and **photo #21** with arrows indicating flashing. There is a spark arrestor/rain cap installed that houses the rooftop damper mechanism that is rusted and deteriorated, **see photo #13** showing spark arrestor/rain cap. The rooftop damper mechanism has a broken/missing spring that does not allow the damper to completely open, **see photo #14** showing damper mechanism. There is there a minor, hairline crack in the top flue tile that is not a hazard at time of inspection, as it is well above the roofline, **see photo #15** with arrow indicating crack.

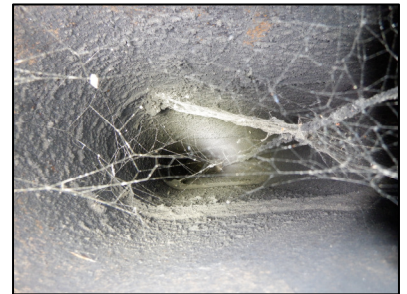
PHOTO #16

Inspection of the interior flue revealed that this flue needed cleaning and was not cleaned at time of inspection, **see photo #16** showing interior flue.

- 1) It is recommended that the flue and smoke chamber be cleaned at a cost of \$205.00.
- 2) It is recommended that the firebox be dried out to prevent moisture from buildup that can deteriorate masonry, to be done by others.**
