**Prepared For:** Pierre and Mary Dube

**Property Address:** 6 White Tail Ln, Monterey, CA 93940

**Inspector:** Robert Vierra  
**Company:** RLV Inspection Services  
dba WIN Home Inspection Monterey  
(831) 637-2194  
rvierra@wini.com

Pre-Listing Inspection

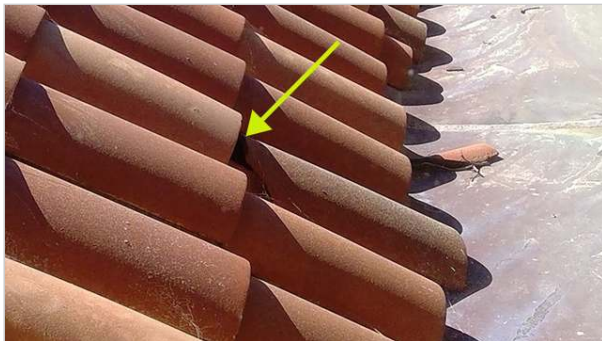
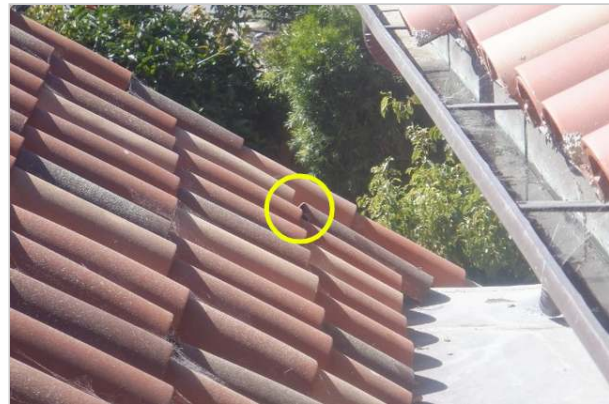
## 2. Roof - Cover Material Condition

There are at least two slipped tile(s) visible on the rear of the roof surface, which may allow moisture intrusion without proper repair. These type of roof covers can be expensive to repair if issues exist or due to lack of preventative maintenance. It is advised a qualified and experienced roofing contractor provide a detailed inspection of the roof surface, and provide bids of repairs.

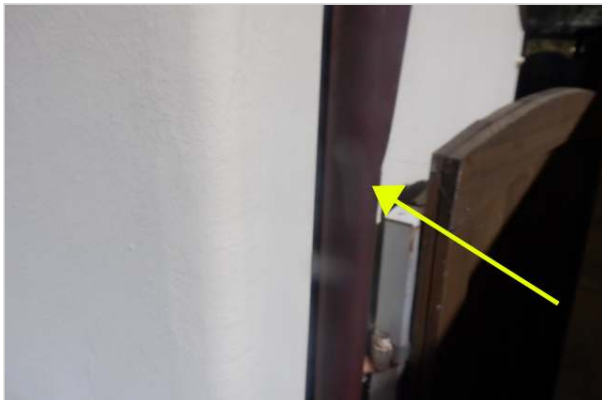
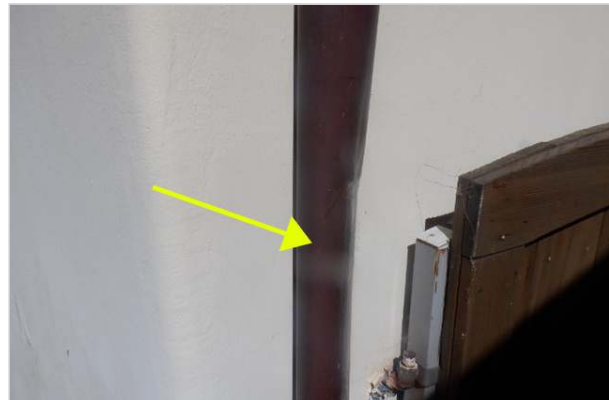
## 3. Roof - Drains/Splash Blocks

Maintenance - damaged downspout

There is a damaged downspout drain at the rear SW corner of the home. Appropriate repairs or modifications are recommended to help move water away from the home.

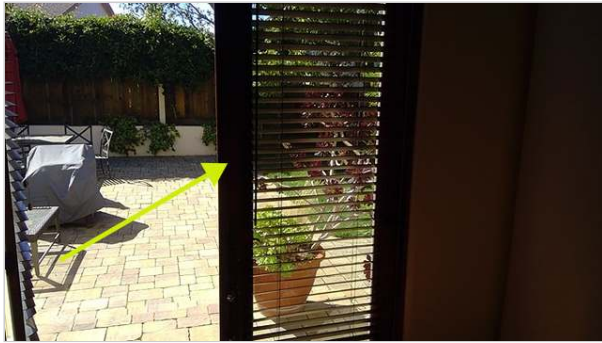
The right side French door from the kitchen is hard to lock/latch. The door pins do not appear to engage in the door frame. The door lock system may need to be properly adjusted and/or will require maintenance or repairs. Contact a qualified trade for further evaluations and repairs.

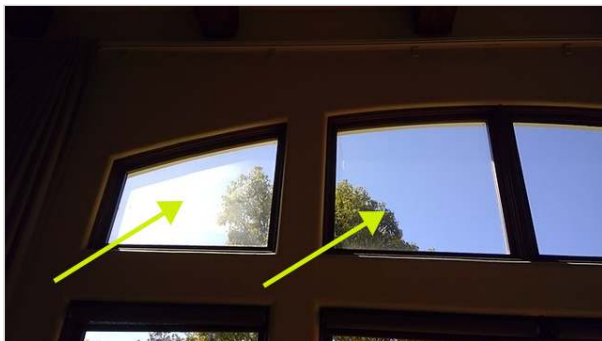
## 6. Other Room(s) - Window(s)

The inspector has at least two windows at the family room area, which have lost the seal or have a defect between the panes of glass. The two left side upper windows display a visible defect. Repairing or replacing the window glass should be considered. We recommend contacting a qualified glass company for an estimate of repairs.

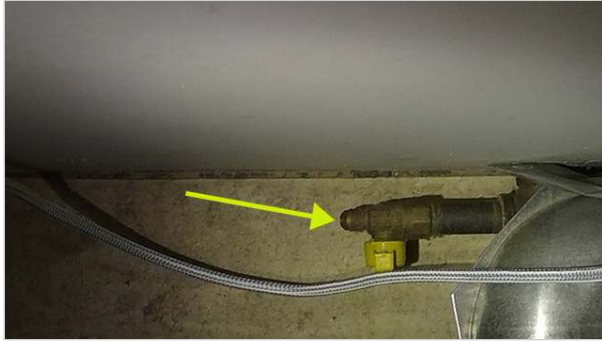
### Attention - cap open line

There is a gas line in the laundry area. The gas valve was turned off to the line; however, the end of the gas line was not capped. Installing a proper cap is recommended to prevent a potential leak when not in use.

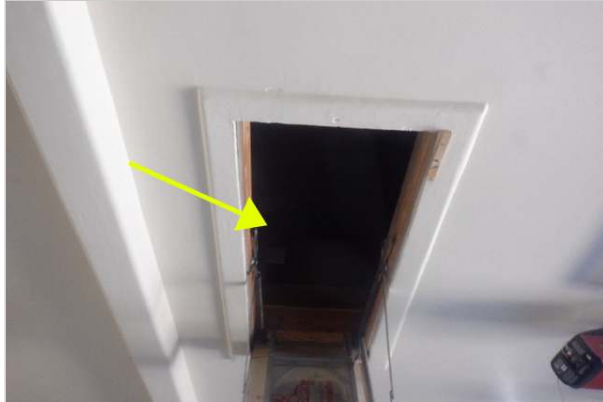
The common surfaces between the house and the garage appears to be a firewall system, however, there is an access ladder in the ceiling leading above the garage which does not meet firewall containment. This causes a void in the firewall system. Appropriate repairs or modifications are recommended to maintain a proper firewall barrier.

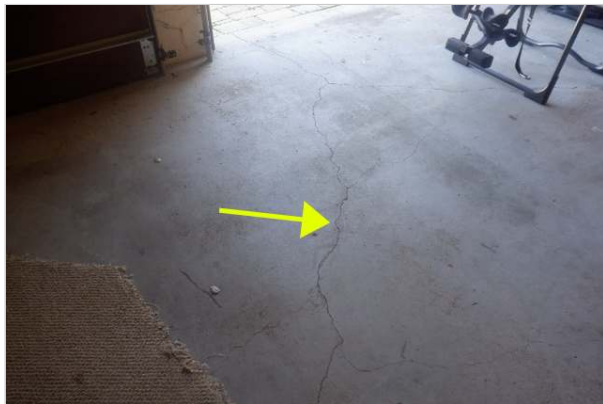
## 10. Floor/Foundation

Satisfactory - cracks

There are separation cracks in the slab of the garage. We recommend the cracks be sealed to prevent further deterioration. Monitoring the cracks for changes is recommended.

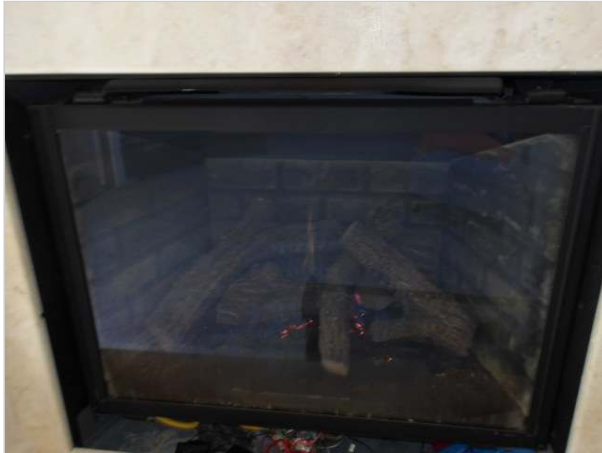
There is a gas-log fireplace in the master bedroom which appears to be in satisfactory condition. The unit was ignited/tested at the time of the inspection. We recommend you verify or further investigate the current condition and any potential issues or disclosure items. Contact a qualified chimney inspection company for a detailed inspection prior to use.

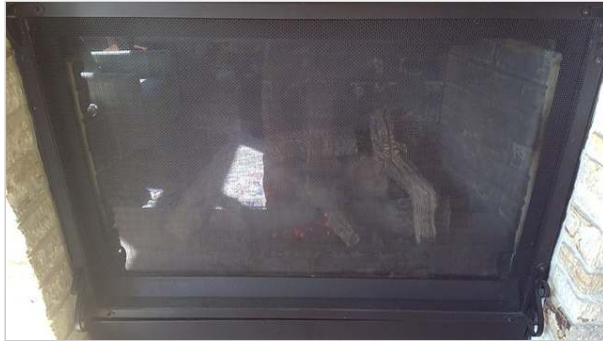
There is a gas-log fireplace in the family room which appears to be in satisfactory condition. The unit was ignited/ tested at the time of the inspection. We recommend you verify or further investigate the current condition and any potential issues or disclosure items. Contact a qualified chimney inspection company for a detailed inspection prior to use.
