Service: Pre-Listing Inspection

Prepared for: Michele A Thomas Revocable Trust

WIN Inspector

Brannon Vierra

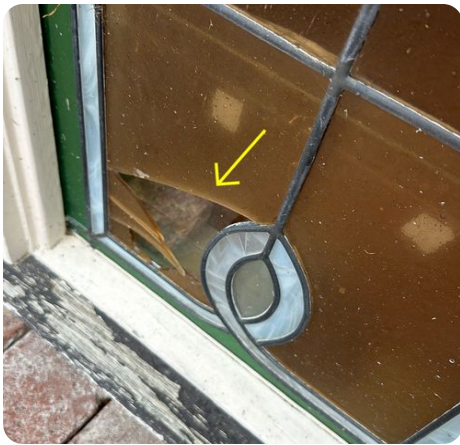
1 Cracked Window

One of the windows was cracked. It is recommended to evaluate and repair the damaged window. Hiring a qualified window contractor to assess and replace the broken or cracked window is advised.

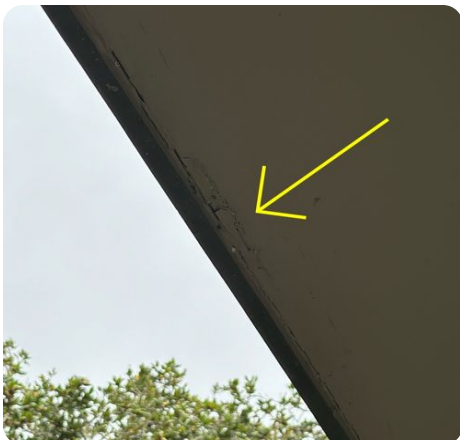
2 Damage At Overhangs

Signs of damage were observed in the overhangs at the exterior of the property, indicated by areas that appear soft or stained. It is recommended to further investigate the cause and extent of the issue and prevent further damage. Refer to a recent pest and dry rot report or contact a qualified contractor for proper repair.

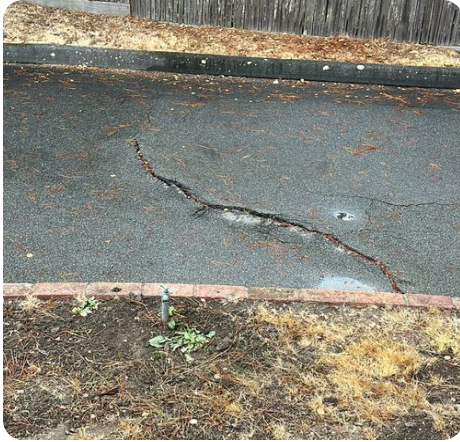
3 Asphalt Surface Cracking

Cracking was observed in the asphalt surface of the driveway, which can occur due to age and weather exposure. Without proper maintenance, these cracks may worsen over time. It is important to assess the extent and severity of the cracking and consider sealing them to prevent further deterioration and water penetration. It is recommended to contact a qualified paving contractor to assess and repair the cracked asphalt surface as necessary.

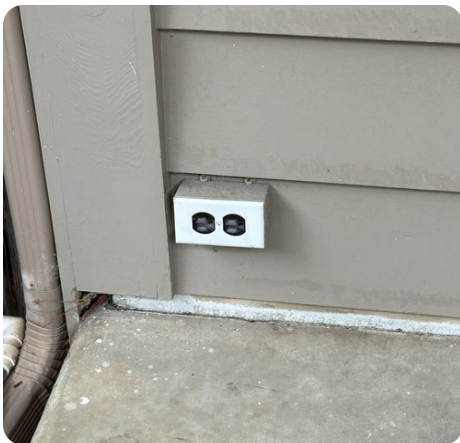
4 Missing Weather Cover For Electrical Outlet

The electrical outlet at the rear of the home is missing a weather cover, which can lead to water damage and pose safety hazards. It is recommended to install a weatherproof cover to protect the outlet from the elements. A licensed electrician can assist with this repair.

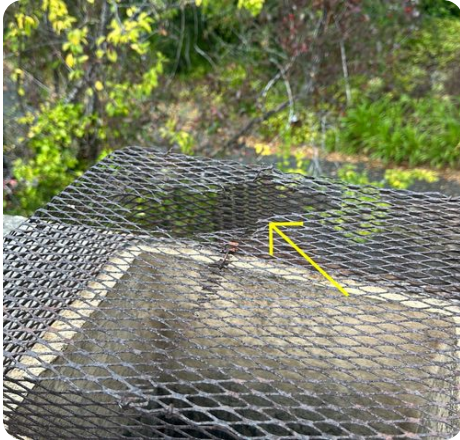
5 Damaged Spark Arrestor

Damaged spark arrestor on the chimney was observed. This could result in debris entering the chimney, leading to additional damage. Evaluating and repairing the spark arrestor or rain cap is advised to prevent potential chimney issues. Engaging the services of a qualified chimney professional is recommended.

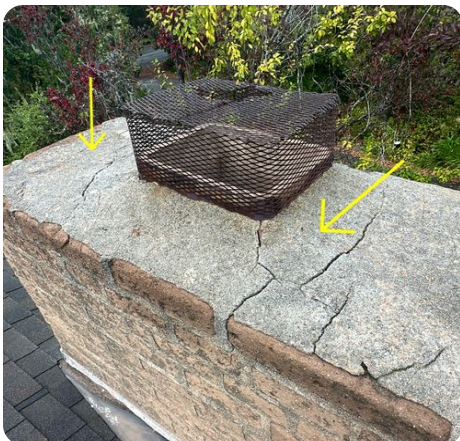
6 Mortar Cap - Cracks

Cracking was observed on the chimney mortar cap. Sealing all cracks with a mortar patch is recommended. Contact a qualified professional to perform the necessary repairs.

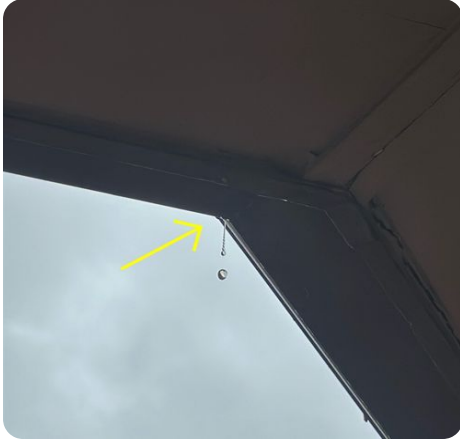
7 Leaking Gutter

The gutter on the roof is leaking. It is recommended to evaluate and repair the leak to prevent water damage to the property. A qualified trade can assess and fix the leaking gutter to ensure proper drainage and prevent further issues.

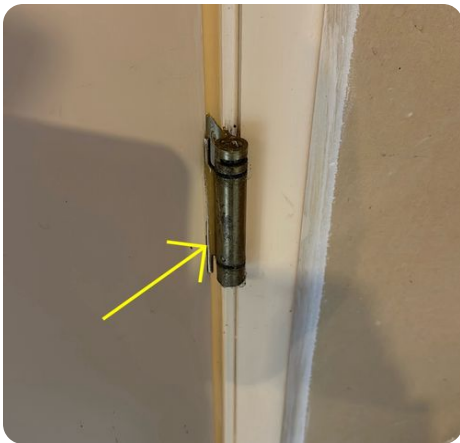
The self-closing door hinge in the garage is not functioning properly. This may impact the fire separation in the garage, which is an important safety feature. It is recommended to evaluate and repair the self-closing door hinge to ensure it closes securely. A qualified contractor or handyperson can assist in repairing or replacing the hinge to maintain fire safety standards.

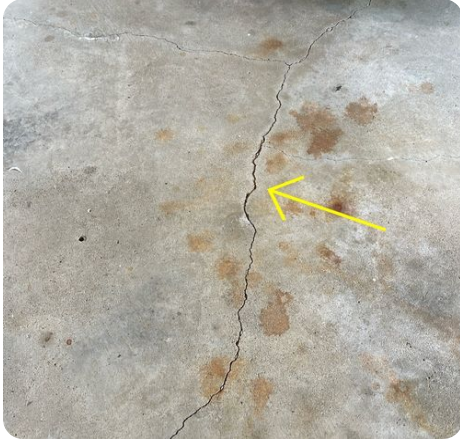
9 Cracks In Garage Floor

The are separation cracks noted in the garage floor. The size of the cracks do not indicate a significant issue at this time. It is recommended to evaluate and repair as needed to prevent further deterioration.

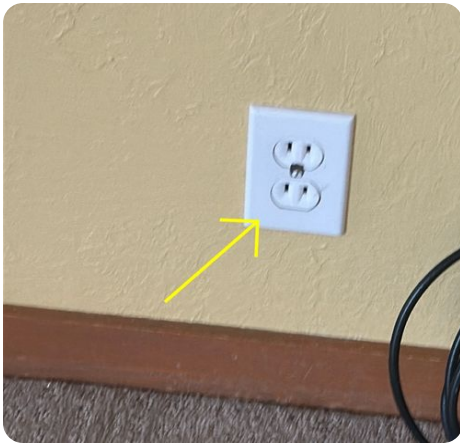
The electrical outlets in the structure are two-pronged and do not have a grounding circuit, indicating an older 2-wire system without current grounding. It is important to have a qualified electrician properly ground or modify the system in crucial areas of the structure, particularly where appliances will be used.

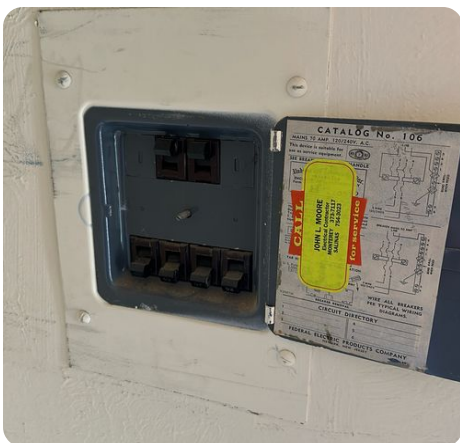
12 Federal Pacific Panel

The property has a Federal Pacific electrical panel, which is known to have safety issues such as faulty breakers that may fail to trip during an overload or short circuit, and other component issues. It is recommended to contact a qualified electrician to evaluate the panel and replace it with a more reliable and safer option.

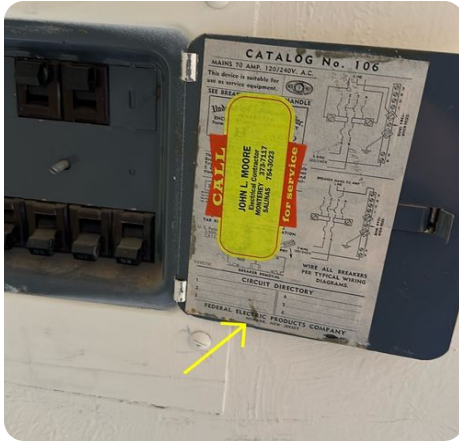
13 Electrical Panel Labeling

The electrical panel lacks full and proper labeling. It is recommended to label all circuits clearly for easier identification and safety purposes.

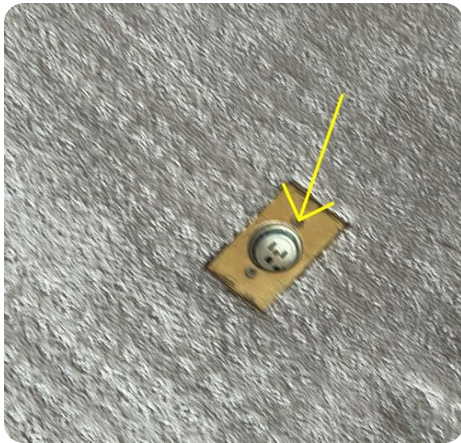
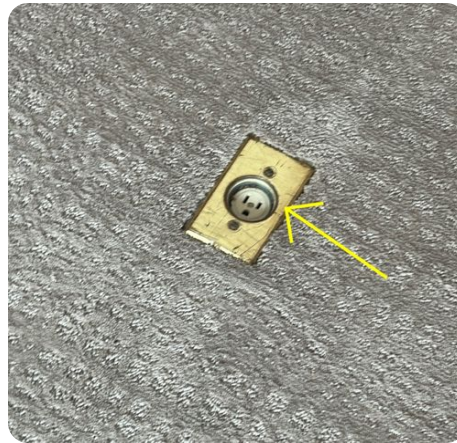
15 Missing Covers On Floor Outlets

The floor outlets are missing proper covers, which can pose a safety hazard. It is recommended to install appropriate covers on the floor outlets to prevent accidental contact with electrical components and reduce the risk of electrical shocks. A licensed electrician should evaluate and repair this issue to ensure the safety of the electrical system.

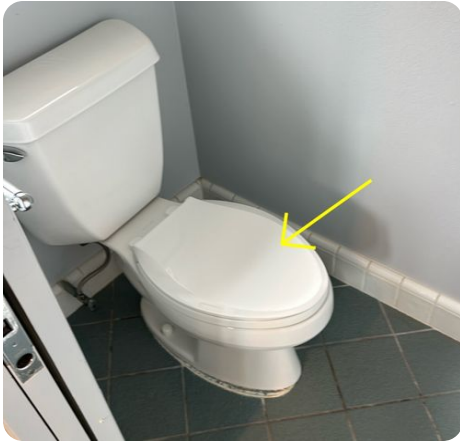
17 Loose Toilet

The toilet was found to be loose, as evident by movement or rocking when pressure is applied. A loose toilet may cause leaking or damage to the wax seal, potentially resulting in water damage to the subfloor or ceiling below. It is recommended to assess and repair the toilet promptly to avoid future problems. A qualified plumber can secure the toilet to the floor correctly for stability.

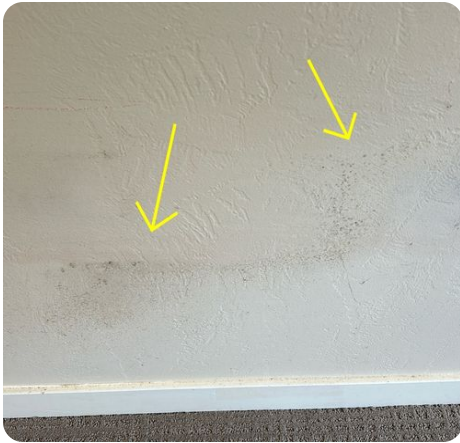
18 Microbial Stains Noted

The presence of possible microbial stains has been observed in the specified area. Testing by a lab would be needed to determine if it is microbial growth and what type. It is recommended to evaluate the extent of the issue and consider repair if necessary to prevent further growth and maintain a healthy indoor environment. A qualified mold remediation specialist should be contacted for further assessment and appropriate treatment.

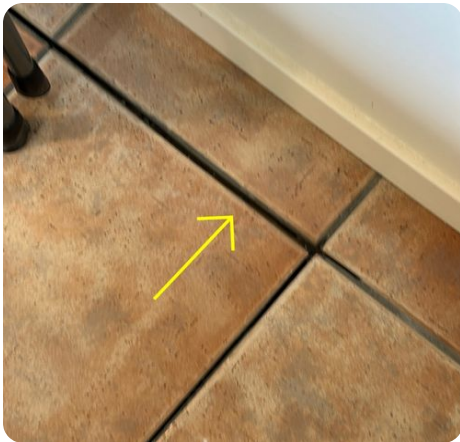
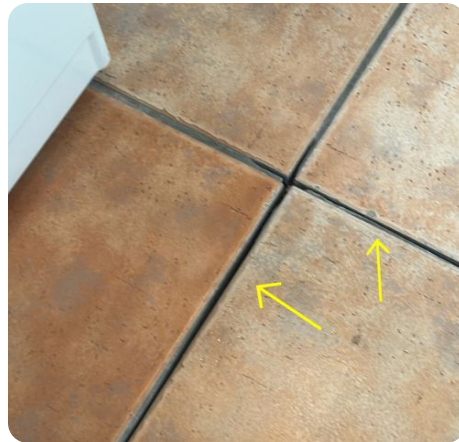
19 Floor Tile Grout Repair

The tile floor requires grout repair to prevent water penetration and potential damage to the subfloor. It is recommended to assess and fix the grout to avoid additional damage. A qualified tile contractor can provide the necessary repairs.

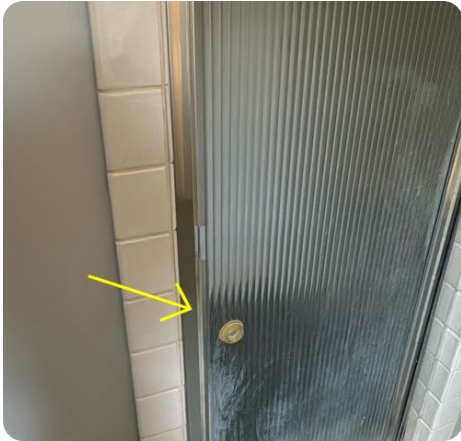
20 Shower Door Needs Adjustment

The shower enclosure door does not stay closed and requires adjustment for proper functionality. It is recommended to contact a qualified professional to address this issue.

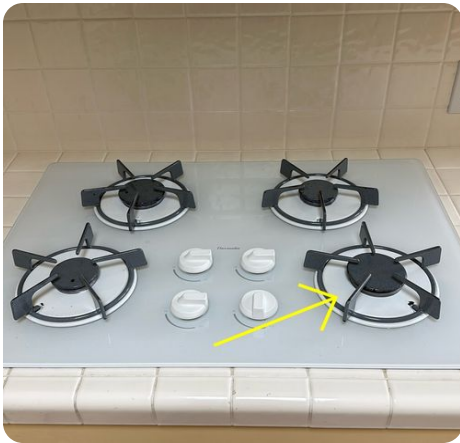
22 Non-Functional Burner

One of the on the gas cooktop did not ignite when tested. This is usually caused by either debris on the igniter or a faulty igniter. It is recommended to have an appliance repair technician evaluate and repair this issue to ensure safety and proper functioning of the cooktop.

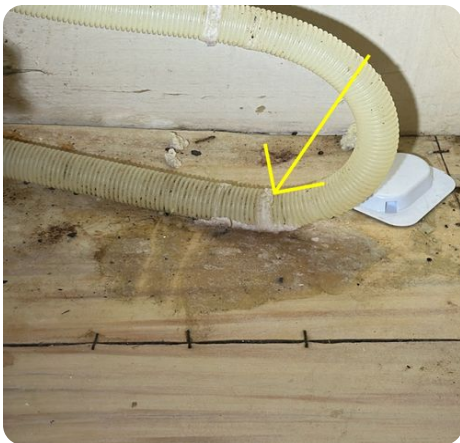
23 Leak At Dishwasher Drain Line

There was a leak from the drain line exiting the dishwasher. Repairs will be necessary before continued use. Contact a qualified plumber or an appropriate trade for repairs.

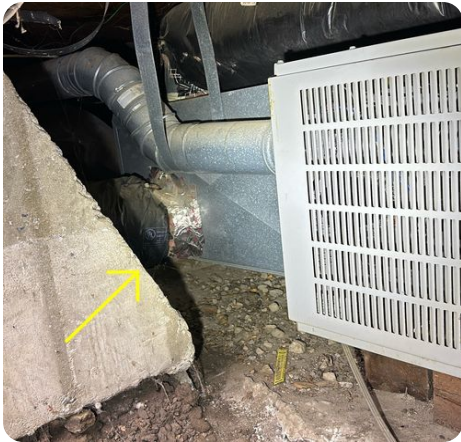
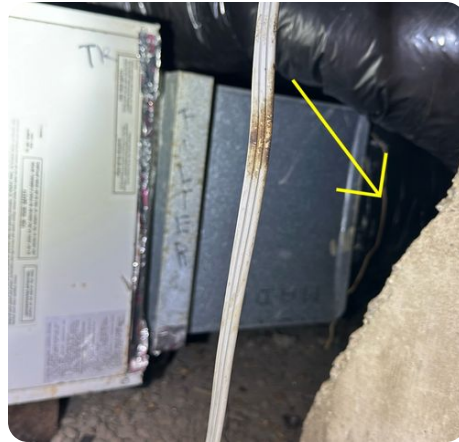
There was an obstructed access under a portions of the crawl, due to the furnace, heat ducts and low clearance. The inspector was only able to access beneath the primary suite area, and the furnace area. Future access would be needed to assess the condition of the crawl space and address any potential issues. Contact a qualified trade to access the remaining sub area when access can be gained.

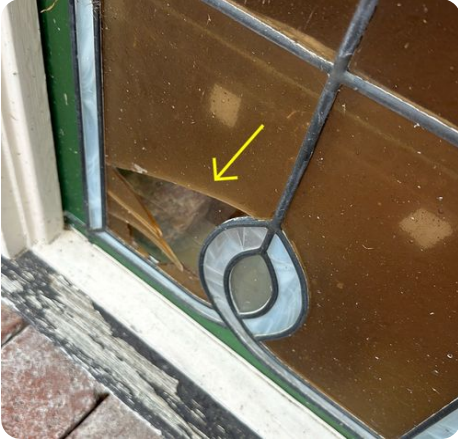
Cracked Window

One of the windows was cracked. It is recommended to evaluate and repair the damaged window. Hiring a qualified window contractor to assess and replace the broken or cracked window is advised.

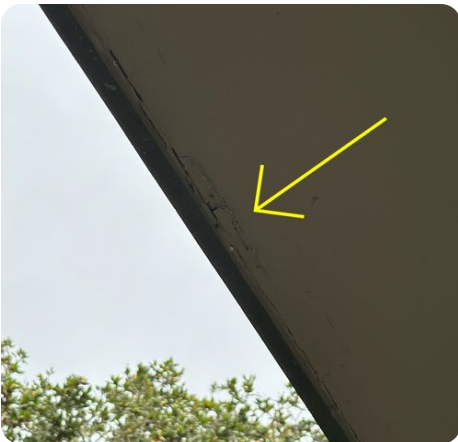
Damage At Overhangs

Signs of damage were observed in the overhangs at the exterior of the property, indicated by areas that appear soft or stained. It is recommended to further investigate the cause and extent of the issue and prevent further damage. Refer to a recent pest and dry rot report or contact a qualified contractor for proper repair.

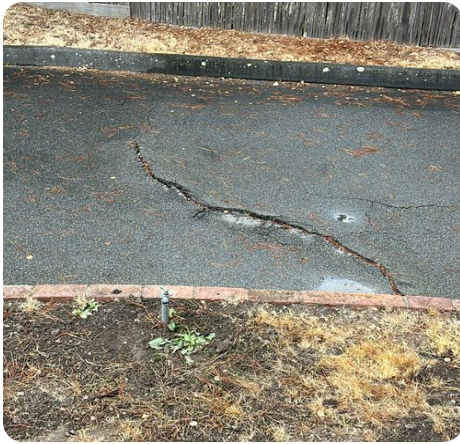
Asphalt Surface Cracking

Cracking was observed in the asphalt surface of the driveway, which can occur due to age and weather exposure. Without proper maintenance, these cracks may worsen over time. It is important to assess the extent and severity of the cracking and consider sealing them to prevent further deterioration and water penetration. It is recommended to contact a qualified paving contractor to assess and repair the cracked asphalt surface as necessary.

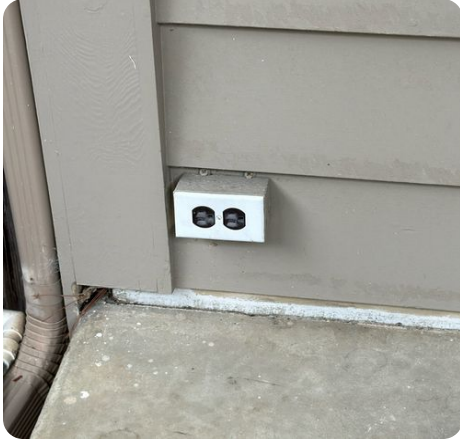
Missing Weather Cover For Electrical Outlet

The electrical outlet at the rear of the home is missing a weather cover, which can lead to water damage and pose safety hazards. It is recommended to install a weatherproof cover to protect the outlet from the elements. A licensed electrician can assist with this repair.

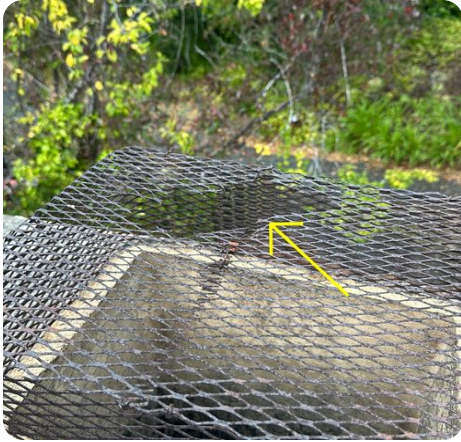
Damaged Spark Arrestor

services of a qualified chimney professional is recommended.

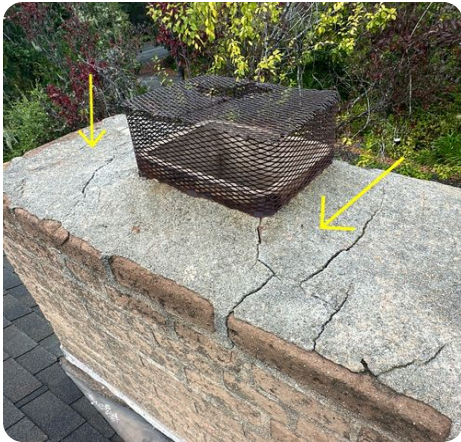
Mortar Cap - Cracks

Cracking was observed on the chimney mortar cap. Sealing all cracks with a mortar patch is recommended. Contact a qualified professional to perform the necessary repairs.

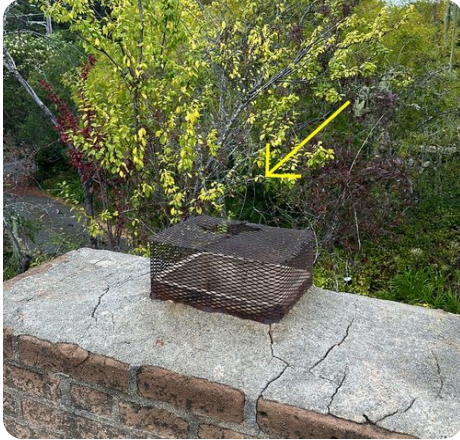
No Rain Cap

The rain cap at the top of the chimney flue is missing. Installing an approved rain cap is recommended to prevent rainwater and pests from entering the flue. It is recommended to contact a qualified professional for this maintenance.

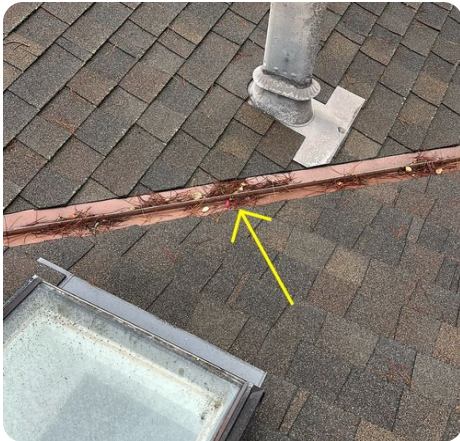
The valleys of the roof are found to have debris accumulation. This can lead to potential water blockage and drainage issues. It is recommended to evaluate and remove the debris to prevent any water damage.

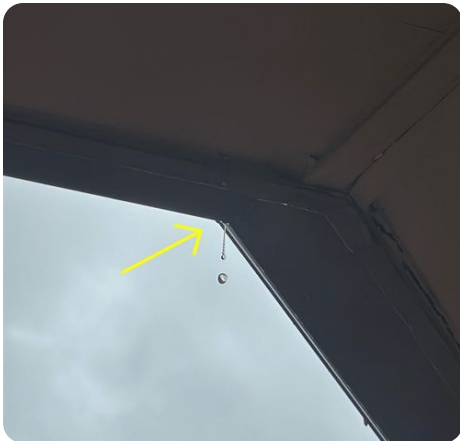
Leaking Gutter

The gutter on the roof is leaking. It is recommended to evaluate and repair the leak to prevent water damage to the property. A qualified trade can assess and fix the leaking gutter to ensure proper drainage and prevent further issues.

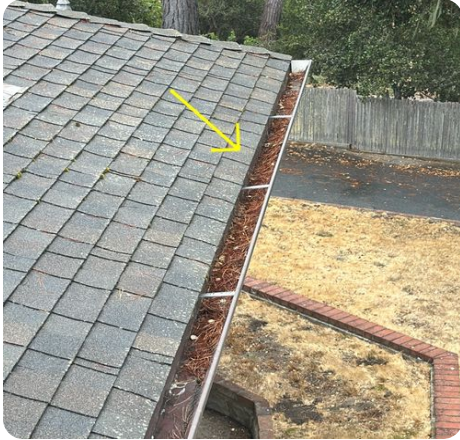
Debris In Gutters

The gutters have debris buildup which should be cleaned to prevent clogging of the gutters, downspouts, and/or drainage systems. It is recommended to clean the gutters semi-annually for proper care and maintenance of the gutter system. Contacting a qualified professional for this maintenance is advised.

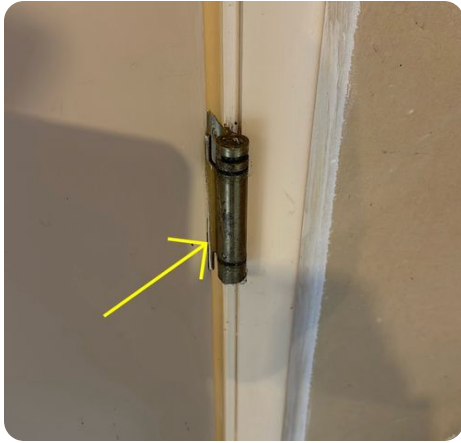
The self-closing door hinge in the garage is not functioning properly. This may impact the fire separation in the garage, which is an important safety feature. It is recommended to evaluate and repair the self-closing door hinge to ensure it closes securely. A qualified contractor or handyperson can assist in repairing or replacing the hinge to maintain fire safety standards.

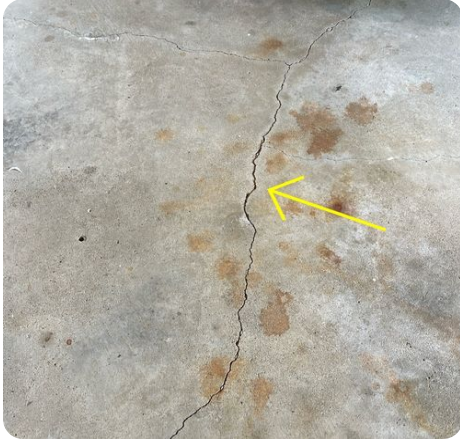
There are separation cracks noted in the garage floor. The size of the cracks do not indicate a significant issue at this time. It is recommended to evaluate and repair as needed to prevent further deterioration.

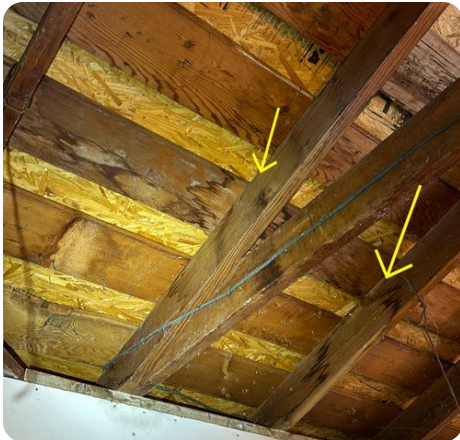
Older Water Stains On Garage Ceiling

The water stains on the garage ceiling were currently dry and appear to be older stains. It is recommended to monitor the area for any changes in the future to ensure no further water intrusion. If the stain reappears or increases in size, further evaluation and repair may be necessary to address any potential underlying issues.

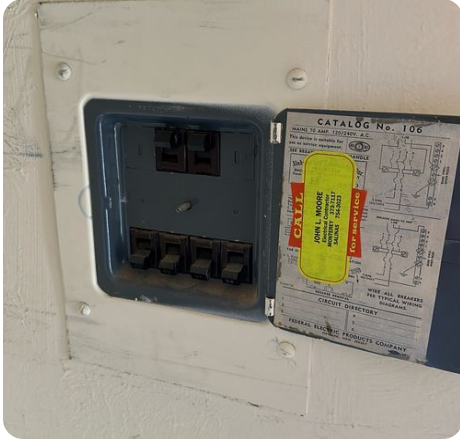
The property has a Federal Pacific electrical panel, which is known to have safety issues such as faulty breakers that may fail to trip during an overload or short circuit, and other component issues. It is recommended to contact a qualified electrician to evaluate the panel and replace it with a more reliable and safer option.

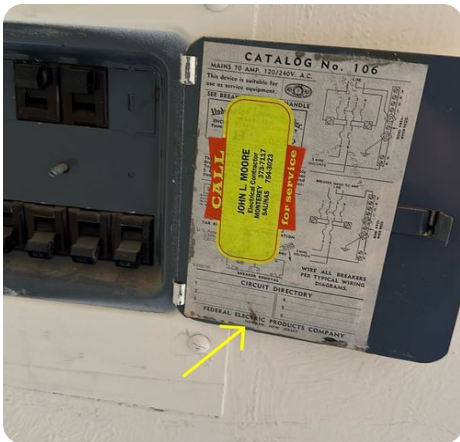
Electrical Panel Labeling

The electrical panel lacks full and proper labeling. It is recommended to label all circuits clearly for easier identification and safety purposes.

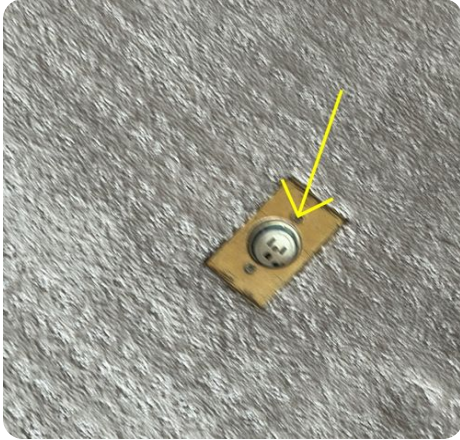
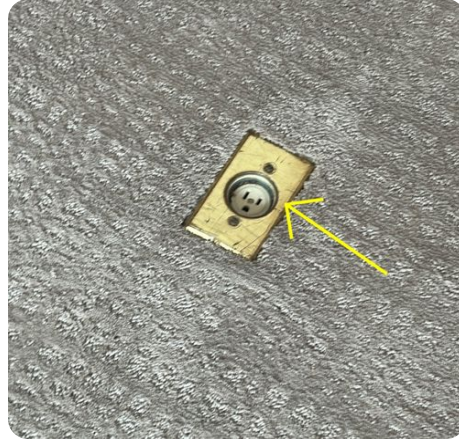
The floor outlets are missing proper covers, which can pose a safety hazard. It is recommended to install appropriate covers on the floor outlets to prevent accidental contact with electrical components and reduce the risk of electrical shocks. A licensed electrician should evaluate and repair this issue to ensure the safety of the electrical system.

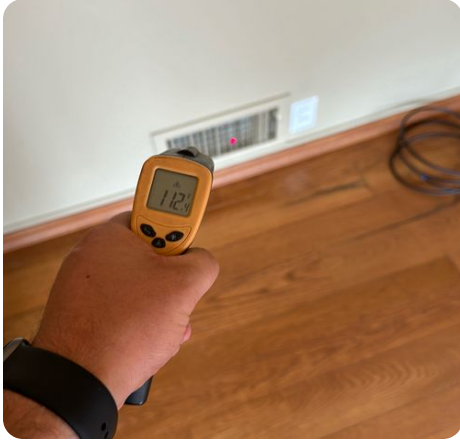
The heating unit was functioning at the time of the inspection; however, this is an older unit. The potential for failure is higher the older the appliance and replacement may be needed at any time. Budgeting for replacement is recommended as failure could occur at any time. We recommend a qualified heating service company inspect the unit prior to closing, as well as every year thereafter, as part of general home maintenance.

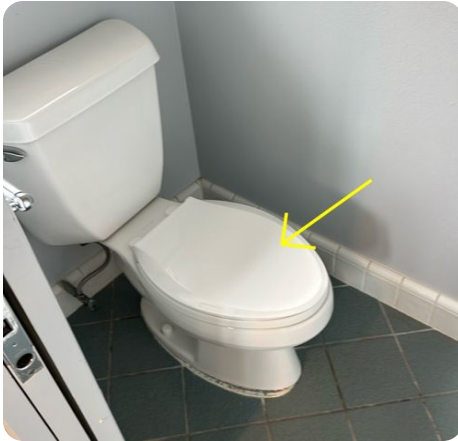
The toilet was found to be loose, as evident by movement or rocking when pressure is applied. A loose toilet may cause leaking or damage to the wax seal, potentially resulting in water damage to the subfloor or ceiling below. It is recommended to assess and repair the toilet promptly to avoid future problems. A qualified plumber can secure the toilet to the floor correctly for stability.

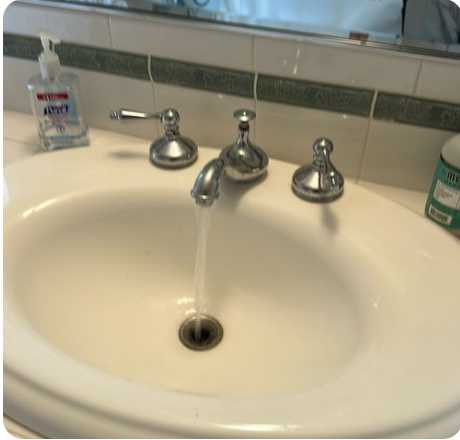
The sink is missing the stopper. We recommend installing a new sink stopper and/or handle to ensure proper functioning of the sink/drain. Contact a qualified professional to make the necessary repairs.

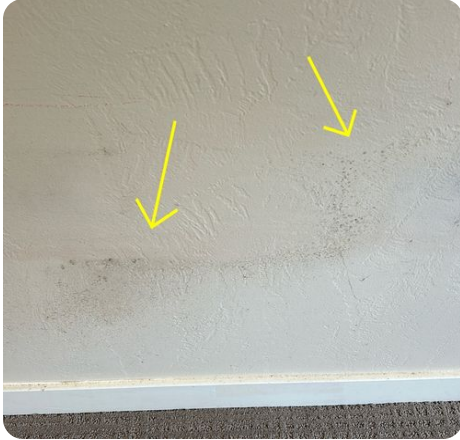
The presence of possible microbial stains has been observed in the specified area. Testing by a lab would be needed to determine if it is microbial growth and what type. It is recommended to evaluate the extent of the issue and consider repair if necessary to prevent further growth and maintain a healthy indoor environment. A qualified mold remediation specialist should be contacted for further assessment and appropriate treatment.

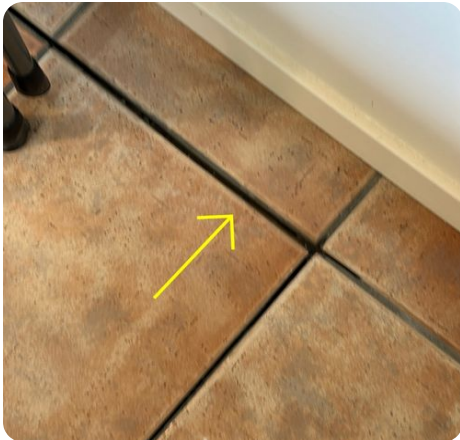
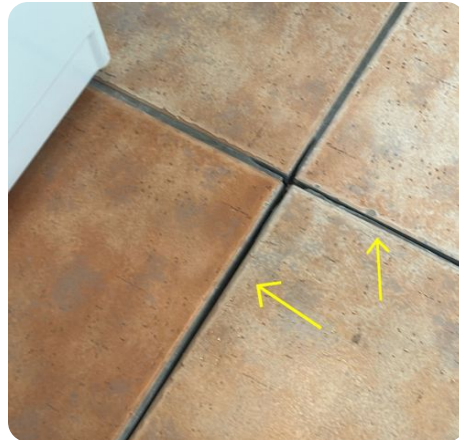
Floor Tile Grout Repair

The tile floor requires grout repair to prevent water penetration and potential damage to the subfloor. It is recommended to assess and fix the grout to avoid additional damage. A qualified tile contractor can provide the necessary repairs.

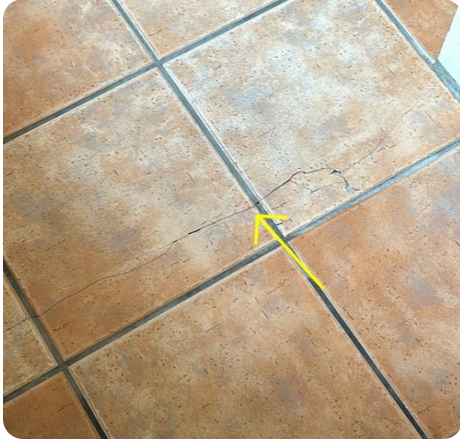
Tile Floor Cracks

The tile floor in the property shows signs of cracks. Cracks in tile flooring can lead to further damage if not addressed promptly. It is recommended to evaluate the extent of the damage and repair the cracked tiles to prevent trip hazards and potential water damage. A qualified tile contractor should be consulted to assess and repair the cracked tiles accordingly. It is also advisable to use similar replacement tiles to maintain a uniform look.

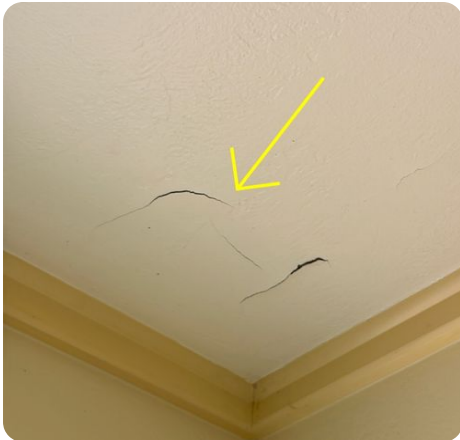
Ceiling Paint Damage

The painted surface of the ceiling shows visible cracks, chips, or peeling paint, indicating a need for repair. Evaluating and repairing the damaged areas is recommended to restore the integrity and aesthetics of the ceiling, which can be achieved by patching and repainting the affected areas. If needed, a qualified painter can be contacted for assistance in ensuring proper repairs and a professional finish.

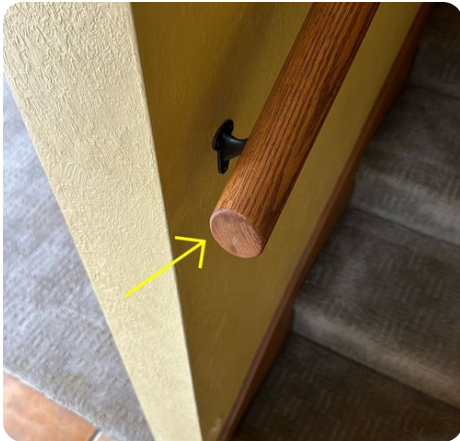
The handrail at the interior stairway is missing returns to the wall at the ends of the rail. A return is meant to help prevent falls and injury. We recommend contacting a qualified contractor for repairs.
