PROPERTY INSPECTION REPORT

Property Address: 2 Paseo De Vaqueros
Salinas, CA

Date of Inspection: May 10, 2019

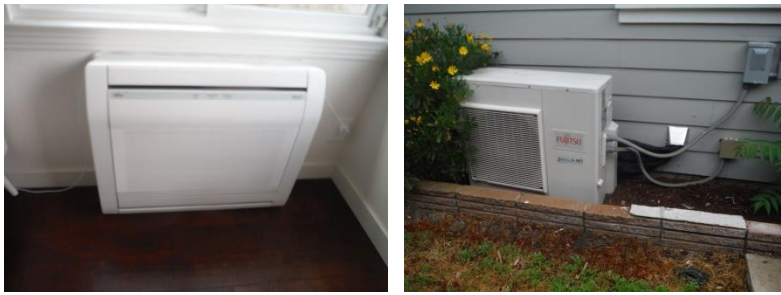
Heating and air conditioning for most of the residence is provided by a mini-split, ductless system. There are three heating and air conditioning units installed in the residence (one in each left side bedroom, and one in the living room). An example is shown in the left side photo at the top of the next page. The air conditioning condensing unit used in conjunction with the three heating and air conditioning units inside the residence is installed at the left side of the residence as shown in the right side photo at the top of the next page. The mini-split, heating and air conditioning system was manufactured by Fujitsu in 2015. The expected service life of this system is a national average of 15 years. Because of our moderate climate, heating and air conditioning systems installed in our area often far exceed this national average. The heating and air conditioning system functioned when tested during the inspection.
