American Inspection Service

Property Inspection Report

Torres 2 S.E. of 9th, Carmel By the Sea, CA, 93923

Date of Inspection: 1/8/2021

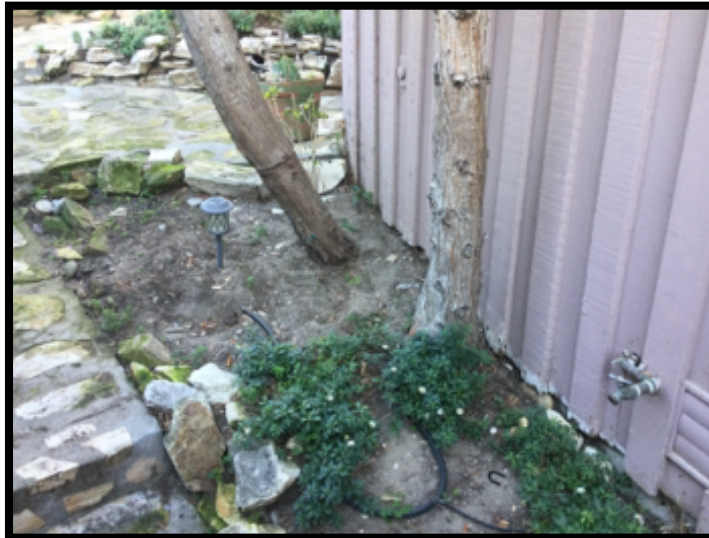
2. Landscaping

- Trees that are adjacent to the foundation should be monitored for any growth that might affect the foundation.

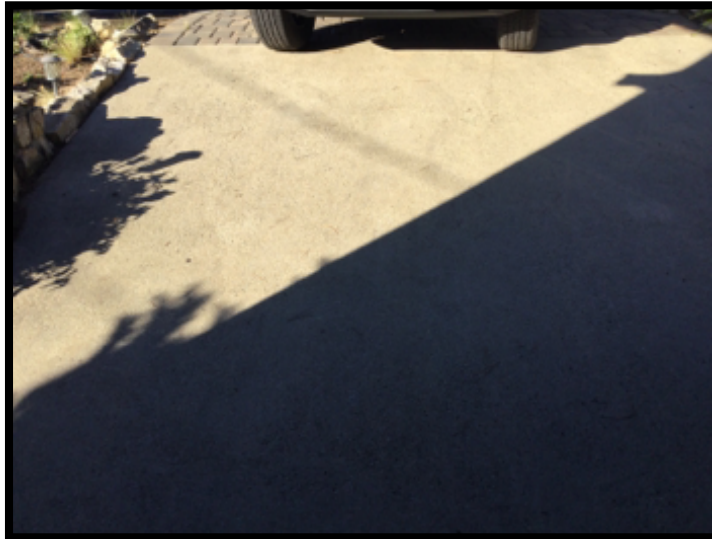
6. Driveway Conditions

- The driveway is in acceptable condition.

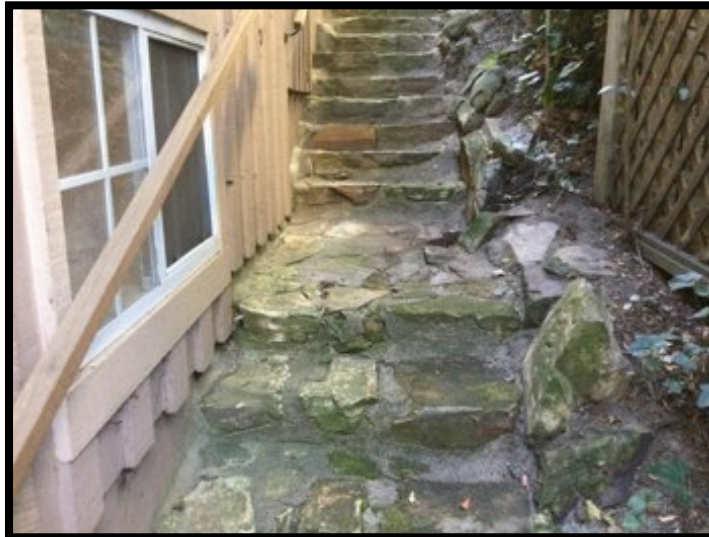
12. Steps and Handrails

- The steps are in acceptable condition.

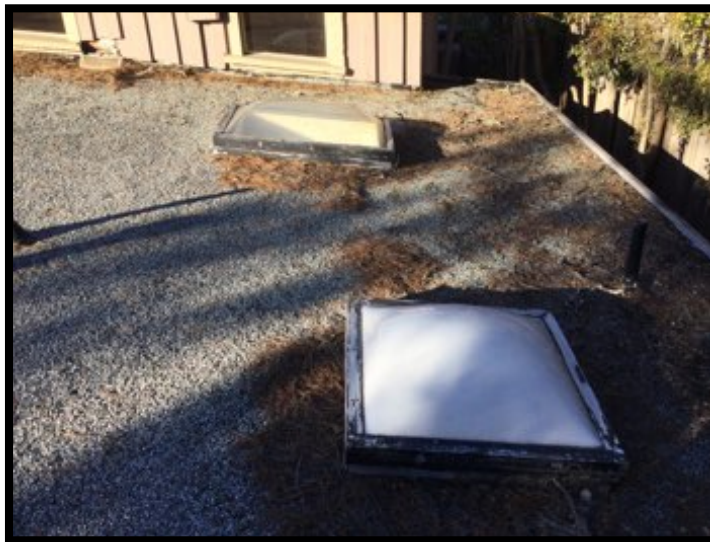
5. Skylights

- The roof includes one or more skylights, which can be problematic and a common point of leaks. There are different methods of installing them and, although opinions will vary, some methods are better than others. Therefore, it will be important to keep the area around them clean and to monitor them for evidence of leaks.

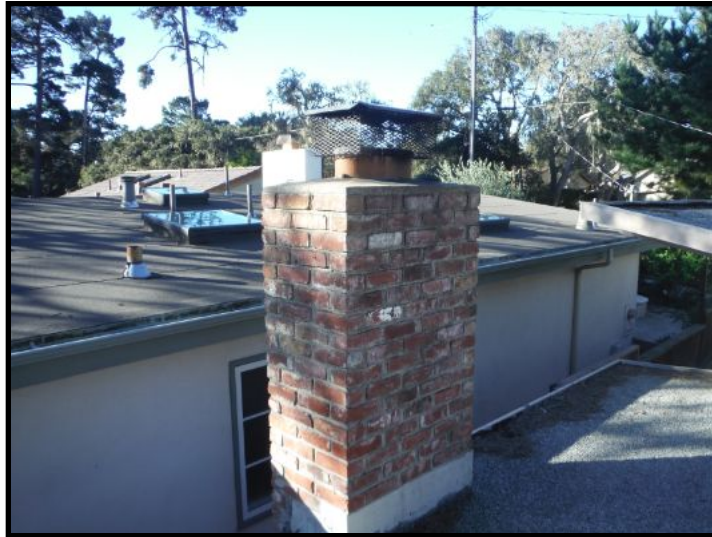
1. Spark Arrestor

- There was a chimney inspection being performed at the time of inspection, and we defer to their report.

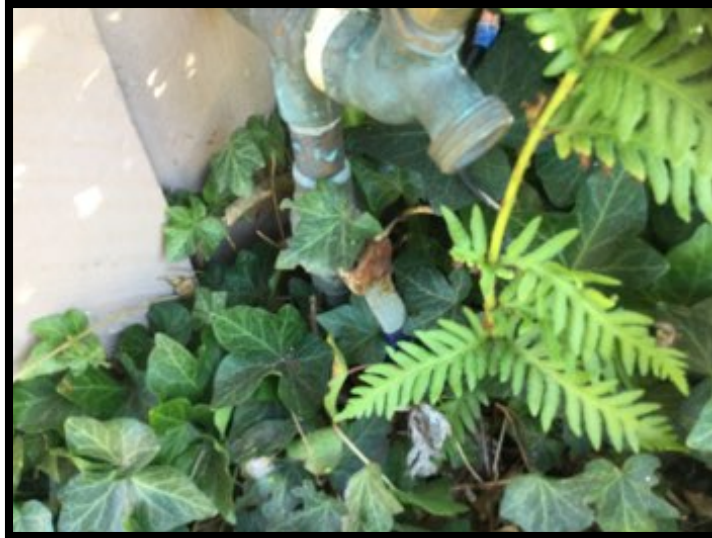
1. Water Main Location

- The main water shut-off valve is located in the garage side yard.

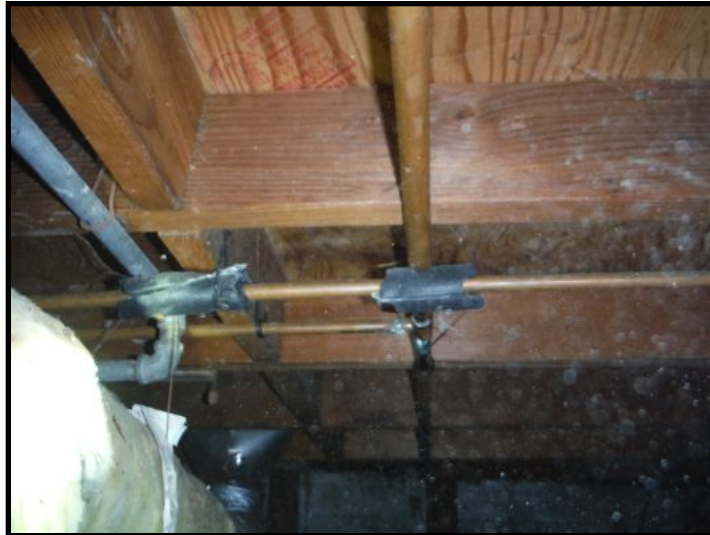
2. Water Pipes

- The visible portions of the potable water pipes are copper and in acceptable condition.

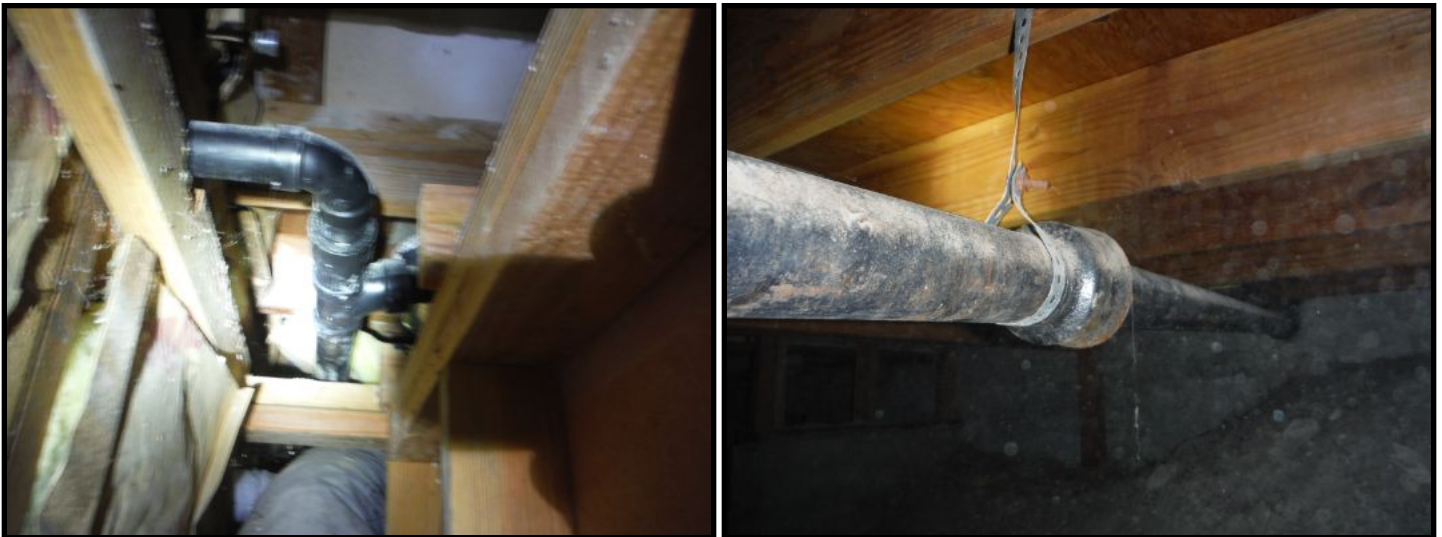
5. Waste and Drainage Systems

- The visible portions of the drainpipes consist of cast iron and **ABS** pipes that are in acceptable condition. However, we obviously cannot determine the condition of interior of the pipe, and we recommend you have a sewer scan performed prior to the end of your contingency period.

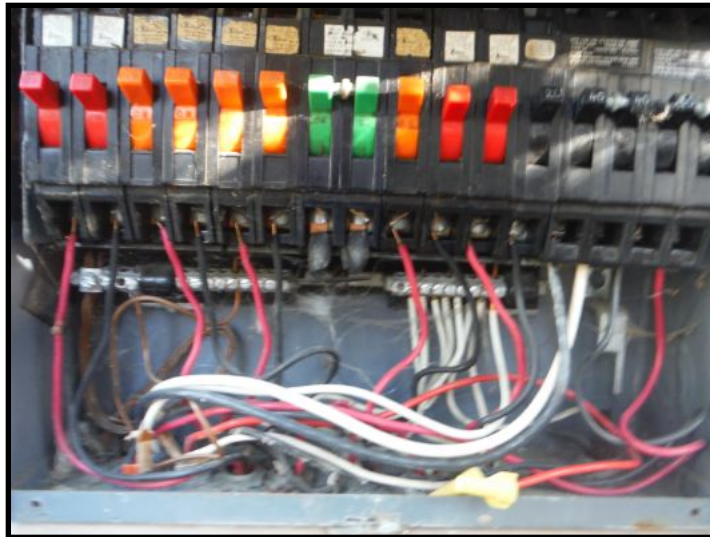
5. Circuit Breakers

- There are no visible deficiencies with the circuit breakers.

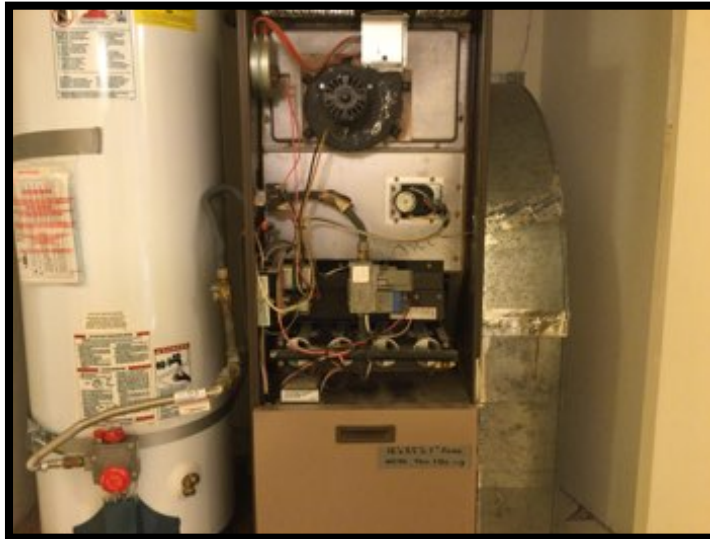
2. Furnace

- The furnace is functional. However, it is beyond the commonly accepted design life of twenty years, and will need to be monitored more closely, and should be evaluated by a licensed HVAC contractor, for evidence of metal fatigue.

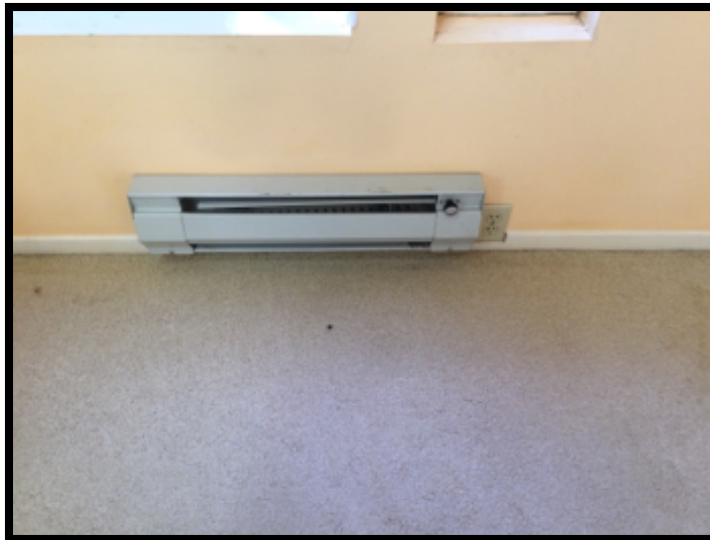
12. Baseboard Heat System

- The baseboard heater did not respond to the thermostat, and should be serviced.

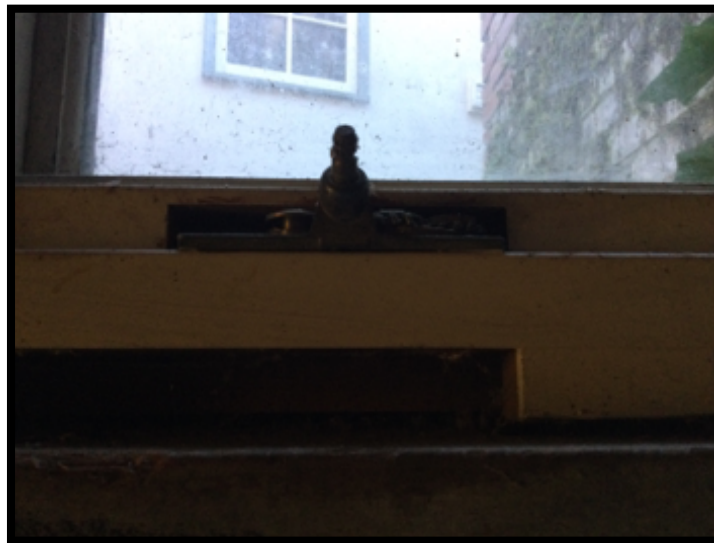
4. Single Pane Windows

- A window or windows are stuck, painted shut, or will need service to work well, such as sanding, shaving, trimming, or servicing the hardware.

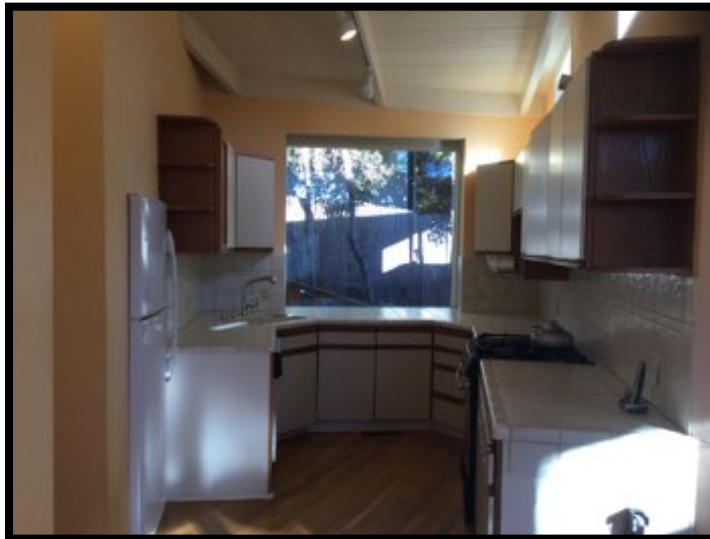
1. Floors

- The floor is in acceptable condition.

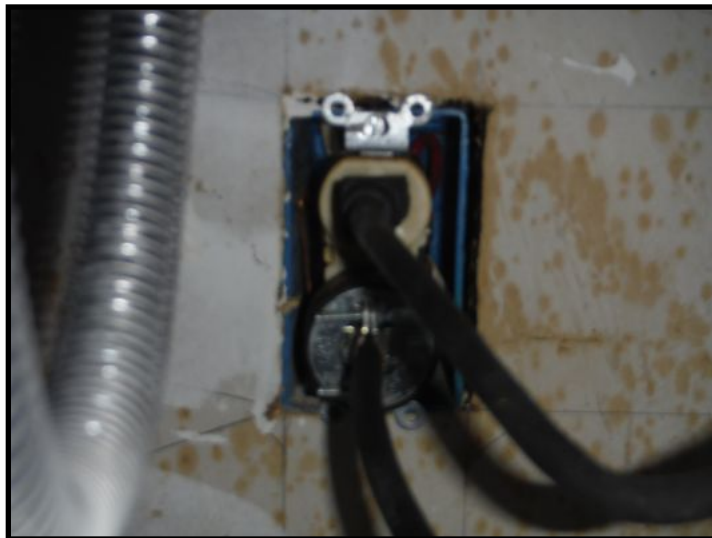
12. Kitchen Outlets

- The outlets that were tested are functional and include ground-fault protection.
- [The outlet under the sink should be covered.](#)

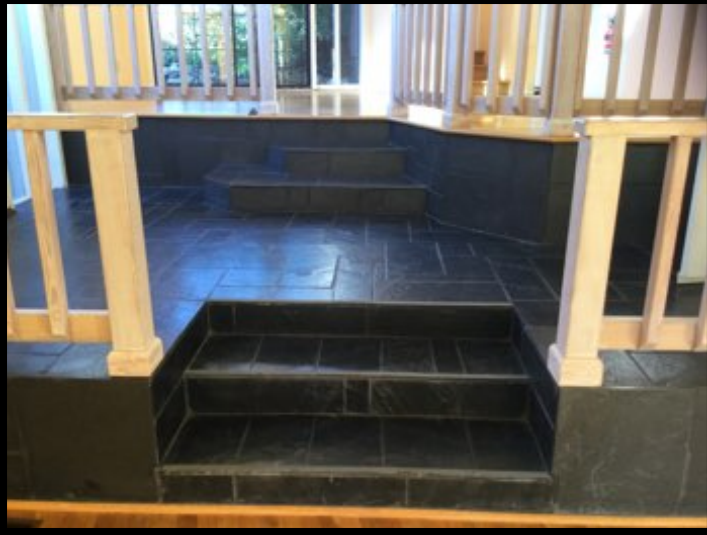
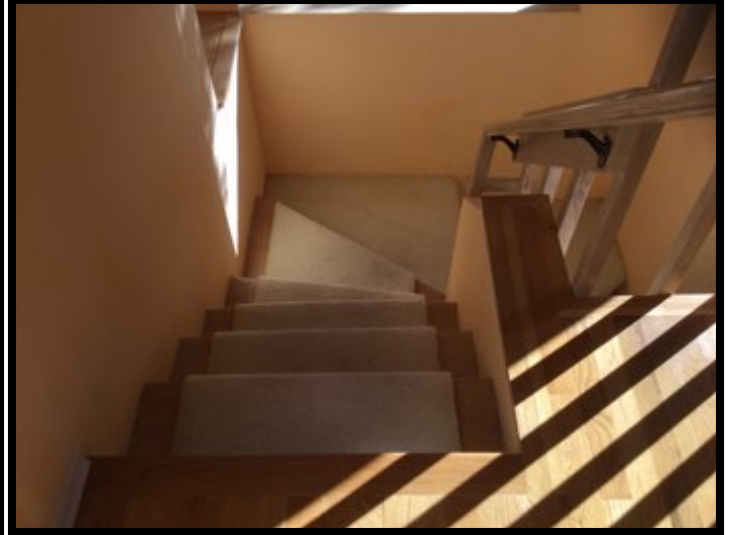
1. Stairs and Handrails

- We have evaluated the stairs and landing, and found them to be in acceptable condition.

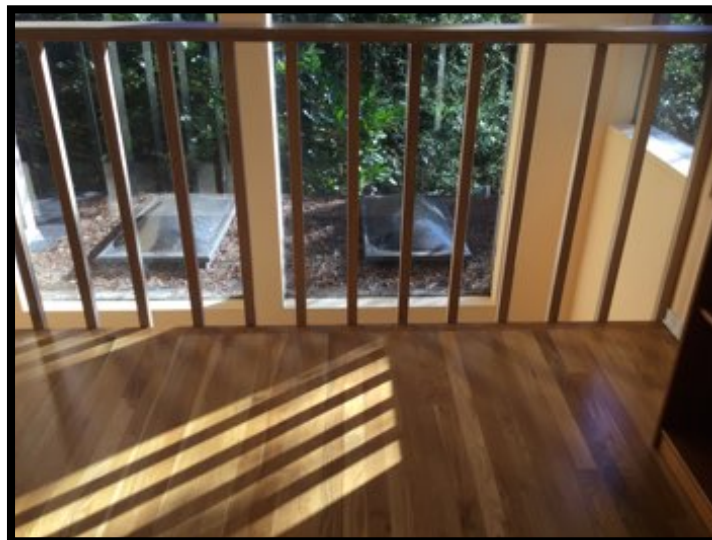
3. Handrails

- The balusters in the stair rails are more than four inches apart and are not child safe. Therefore, you may wish to add a protective barrier.

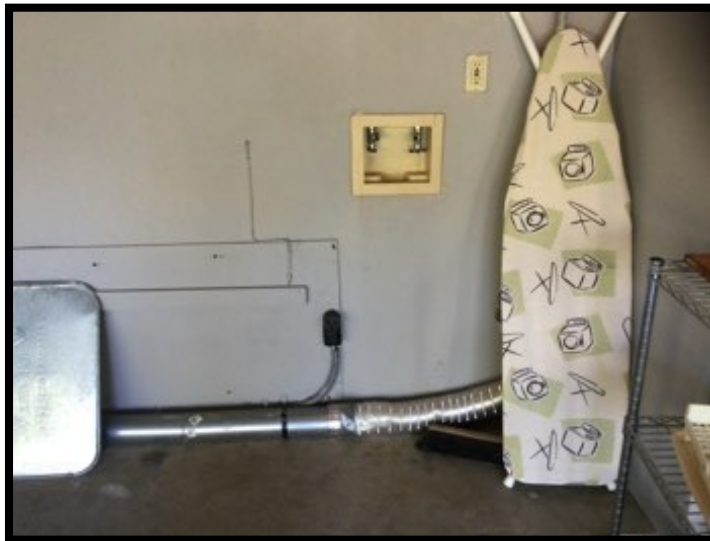
1. General Comments

- We have evaluated the laundry area and found it to be in acceptable condition.

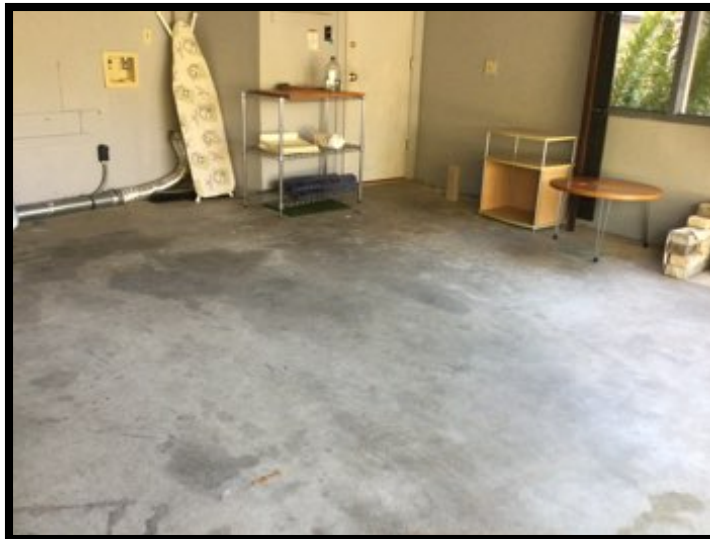
1. Slab Floor

- The slab floor is in acceptable condition. Small cracks are common and result as a consequence of the curing process, seismic activity, common settling, or the presence expansive soils, but are not structurally threatening. Also, you may notice some salt crystal formations that are activated by moisture penetrating the slab.

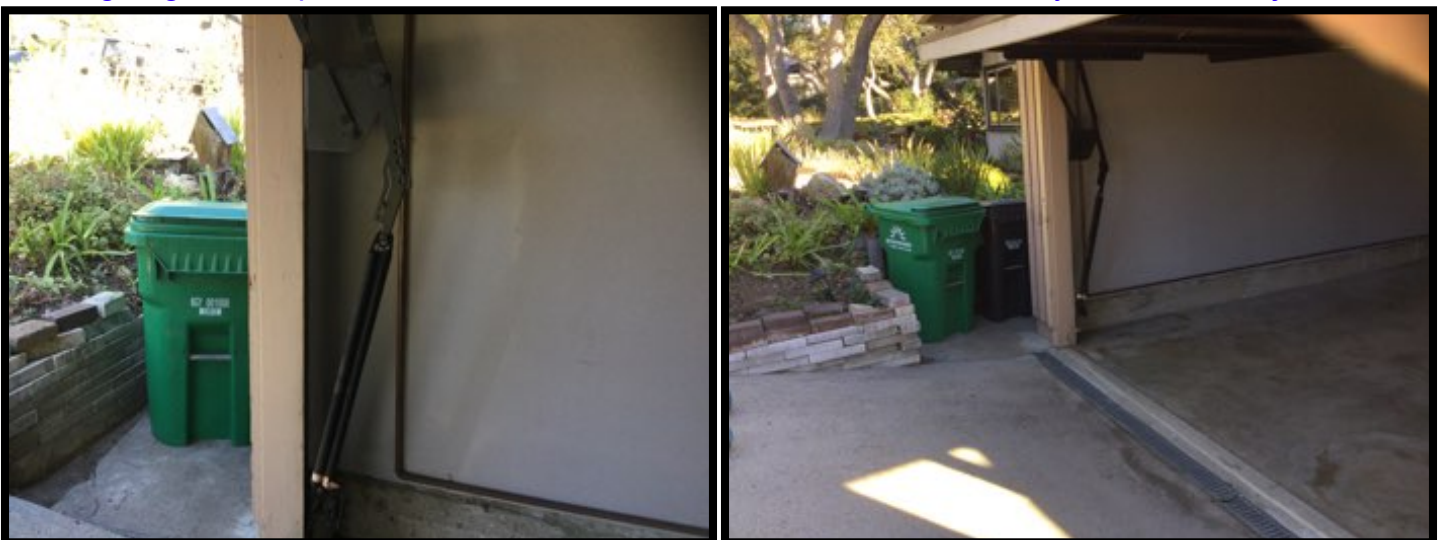
6. Garage Doors and Openers

- The garage door or doors are a heavy, wooden, type that can be potentially dangerous because of the weight of the door. Therefore, the springs should be periodically tested to make sure that they are able to bear the full weight of the door at almost any angle, and particularly if children or the elderly occupy the residence.
- The garage door opener is functional, but it does not auto reverse or may need to be adjusted.

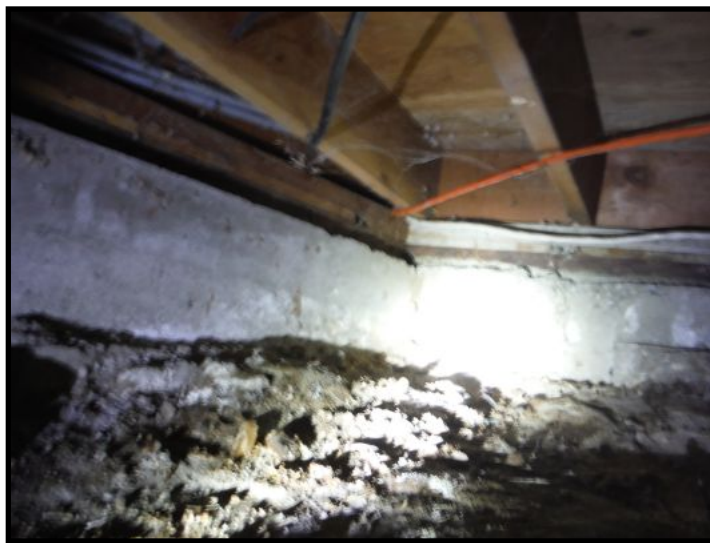
4. Stem Walls

- The visible portions of the stem walls are in acceptable condition.
