**Prepared For:** Pierre and Mary Dube

**Property Address:** 6 White Tail Ln, Monterey, CA 93940

**Inspector:** Robert Vierra  
**Company:** RLV Inspection Services  
dba WIN Home Inspection Monterey  
(831) 637-2194  
rvierra@wini.com

Pre-Listing Inspection

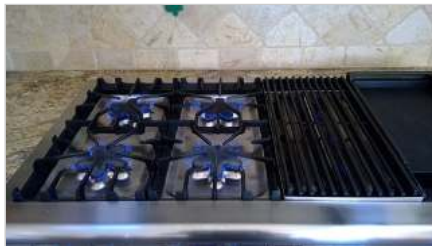
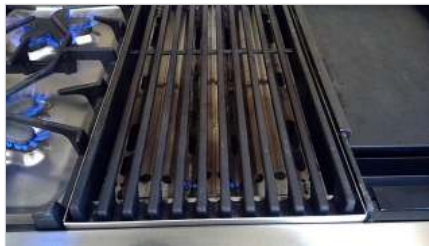
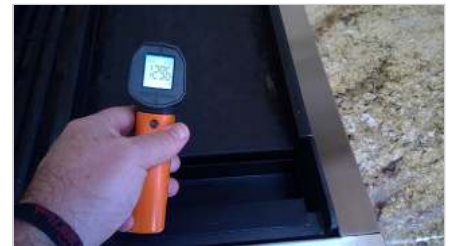
An "on-off" test was performed to determine if the stove top burners were functioning. Periodic cleaning and maintenance of the burners are needed.

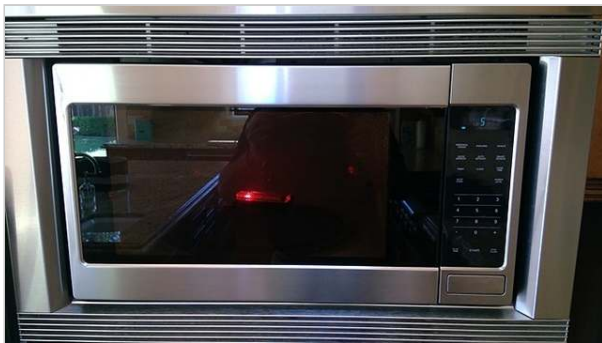
This is an "on/off" test conducted on the microwave oven. Typically, the inspector will warm up water, wet paper towel, special microwave block, or sponge to test the unit. We suggest you ask the owner as to the current condition of the unit. **Note:** Timer, clocks, fans, etc., are not tested.
