Service: Pre-Listing Inspection

Prepared for: Michele A Thomas Revocable Trust

WIN Inspector

Brannon Vierra

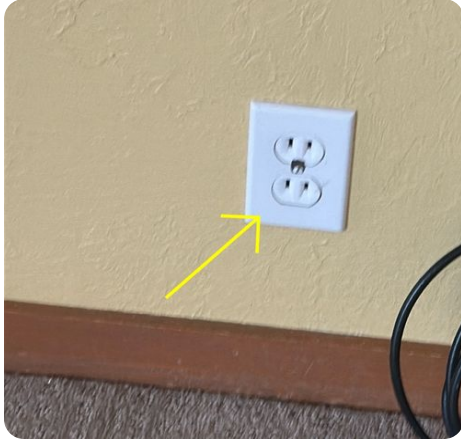
Location: Multiple Locations

The electrical outlets in the structure are two-pronged and do not have a grounding circuit, indicating an older 2-wire system without current grounding. It is important to have a qualified electrician properly ground or modify the system in crucial areas of the structure, particularly where appliances will be used.

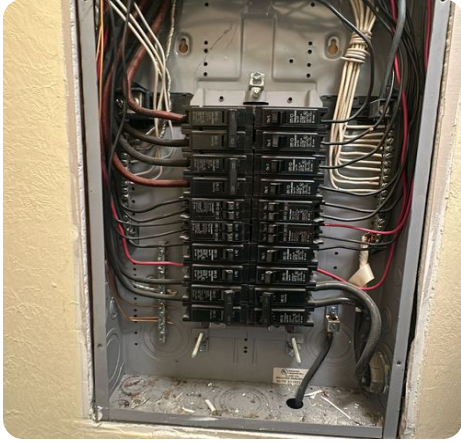
The interior components of the service panels were evaluated during the inspection, and they were found to be in working condition. It is always recommended to conduct regular maintenance and/or evaluation on the electrical panels to ensure continued performance.

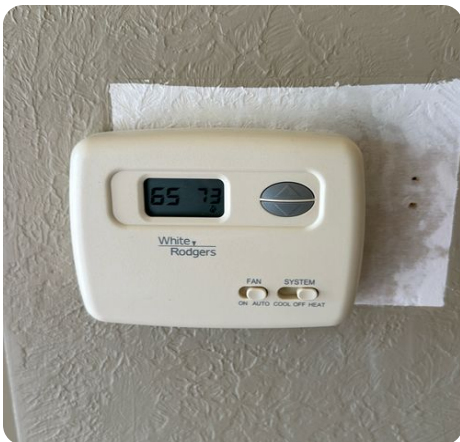
The thermostat for the structure was evaluated and tested using normal homeowner operation, and found to be in working condition. Properly functioning thermostats are essential for maintaining a comfortable temperature in the house and can help save energy costs. It is recommended to continue regular maintenance and setting appropriate temperatures for optimal performance.

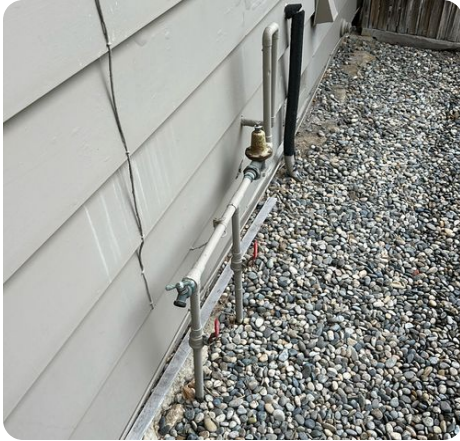
Water Main Shut-Off Functional

The water main shut-off valve was located and evaluated during the inspection. It is important to know the location and condition of the shut-off valve in case of emergencies or repairs. We recommend testing the shut-off valve periodically to ensure proper functionality.

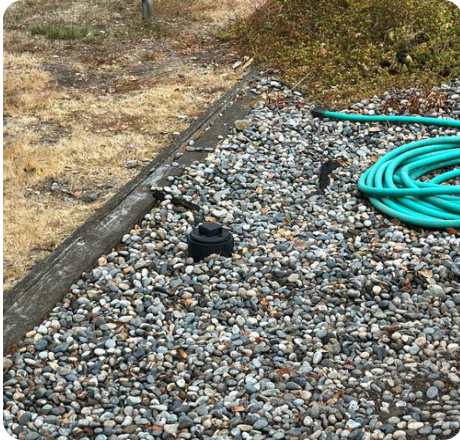
Visual Inspection Of Drain Pipes Informational

This is a visual examination of the exterior piping. We recommend questioning the seller regarding their knowledge of any slow draining or other plumbing-related issues. Also, a video examination of your waste system is recommended to determine if any obstructions exist inside the waste lines.

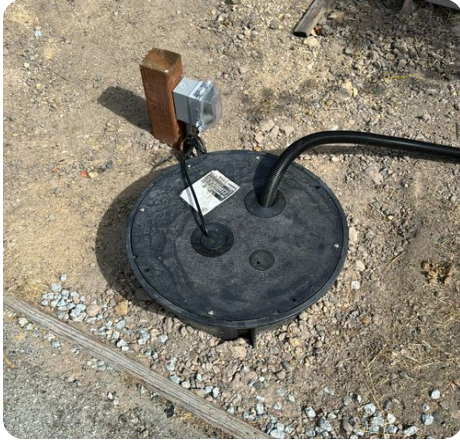
Location: Front of Home

The sump pump installed at the property was functional at the time of inspection. Periodic inspections of the sump pump are recommended. It is recommended to keep the bottom of the sump pit free of debris that can clog the intake ports of the pump and checking the pump discharge line after heavy rain for proper drainage. Consideration should be given to a backup pump and/or battery backup for power failures if the pump cycles on and off frequently during damp periods. This inspection is not an assurance that the sump pump will continue to work in the future. Sump pumps can fail at any time.

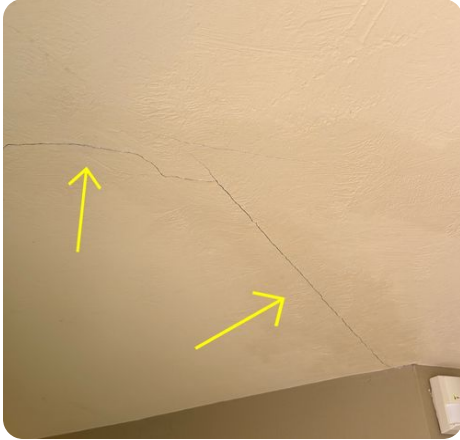
Location: Living Room

There are cracks in areas of the drywall. This condition is common as the structure settles and due to age of the structure. These areas are considered cosmetic in nature, and do not appear to present structural issues at this time. Repairs can be made for the desired condition by a qualified trade.

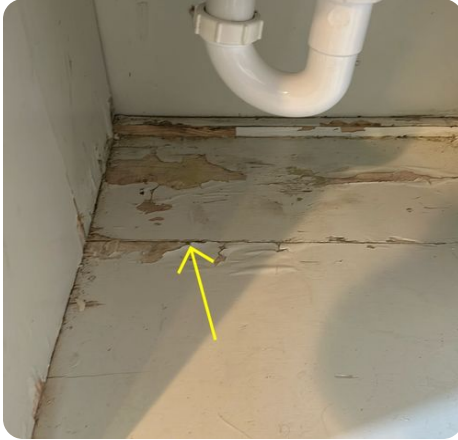
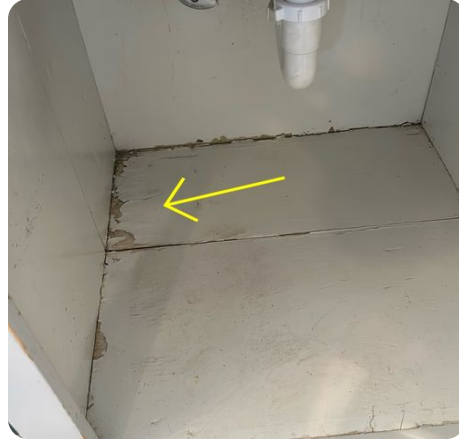
Location: Primary Bathroom

The presence of a stain under the sink is noted. It is recommended to evaluate the source of the stain, which could indicate a past or current leak. Recommend further evaluation repair by a qualified specialist.

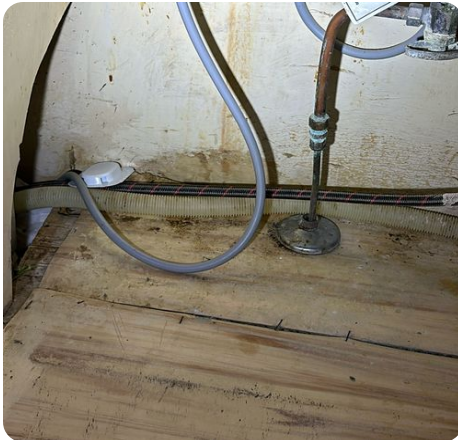
Moisture Staining Under Kitchen Cabinet Sink

The home inspection revealed moisture staining under the kitchen cabinet sink, indicating past leaking. There was no active leaking observed during the inspection. It is recommended to evaluate and repair as necessary, and cosmetic cleaning may be warranted to address the staining.

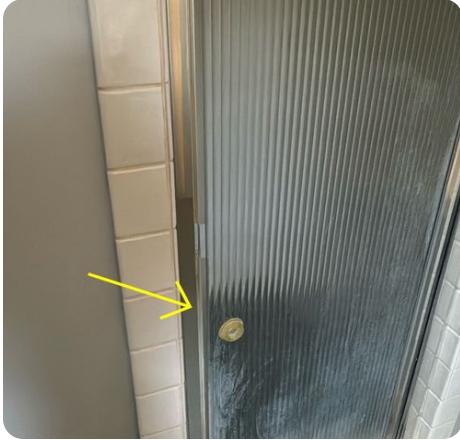
Location: Primary Bathroom

The shower enclosure door does not stay closed and requires adjustment for proper functionality. It is recommended to contact a qualified professional to address this issue.

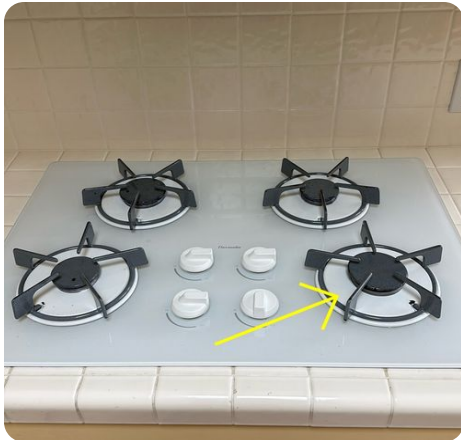
One of the on the gas cooktop did not ignite when tested. This is usually caused by either debris on the igniter or a faulty igniter. It is recommended to have an appliance repair technician evaluate and repair this issue to ensure safety and proper functioning of the cooktop.

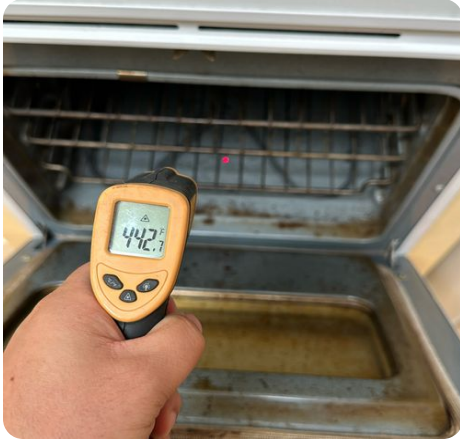
The oven functioned normally when tested in a limited fashion at both the bake and broil settings. The tests are designed to determine basic functionality and should not be considered a verification of actual temperatures achieved.

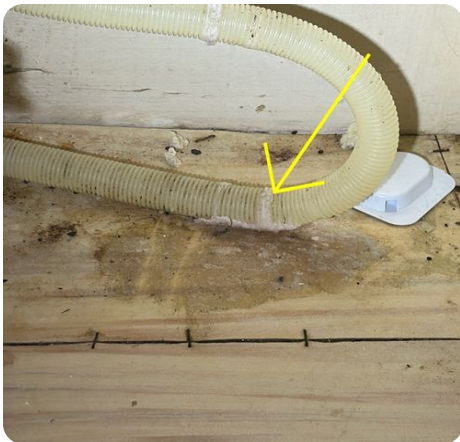
There was a leak from the drain line exiting the dishwasher. Repairs will be necessary before continued use. Contact a qualified plumber or an appropriate trade for repairs.

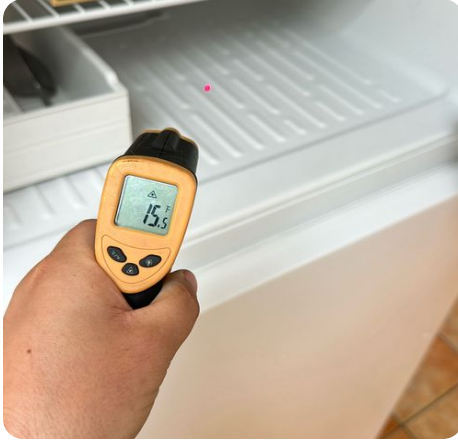
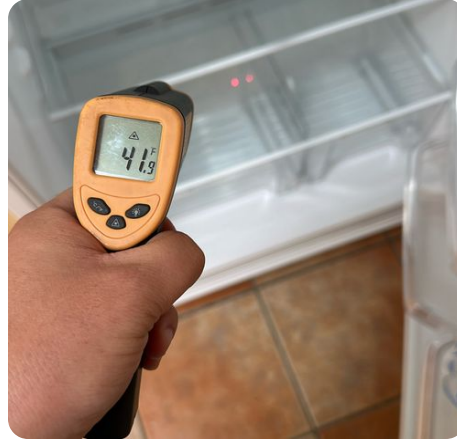
Refrigerator Evaluated

The interior of the refrigerator and freezer were cold when opened and functional at the time of inspection.

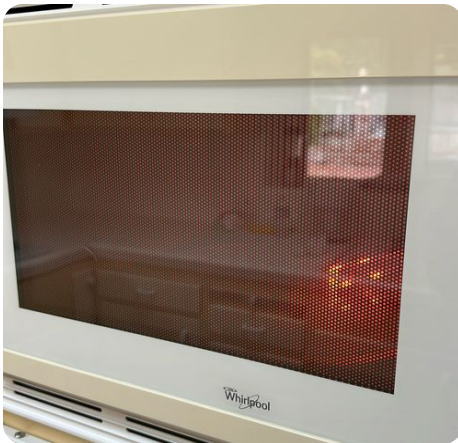
This is an on/off test conducted on the microwave oven. Typically, the inspector will warm up water, a wet paper towel, a microwave block, or a sponge to test the unit.

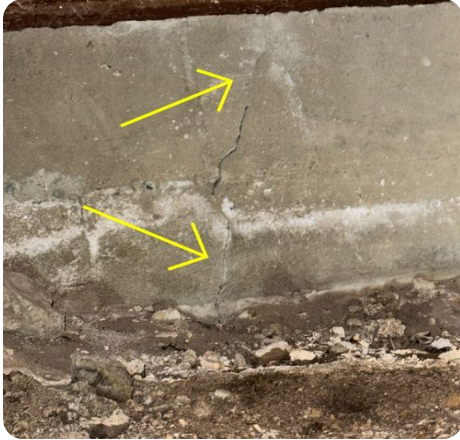
Location: South Side, Crawl Space

The foundation crack was noticed at the foundation. While small cracks are common due to settling, it is important to monitor for any changes. We recommend evaluating the crack for any signs of widening or moisture penetration. If the crack expands, it is recommended to consult with a qualified foundation contractor to repair and seal the crack to prevent potential water ingress issues.

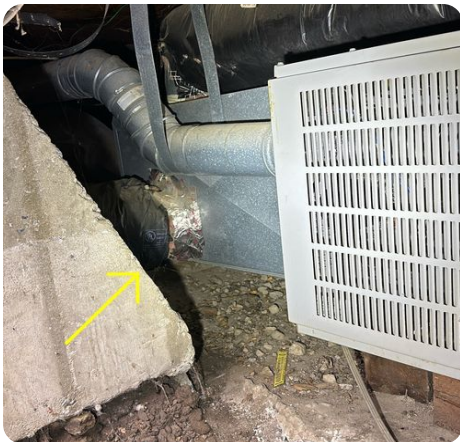
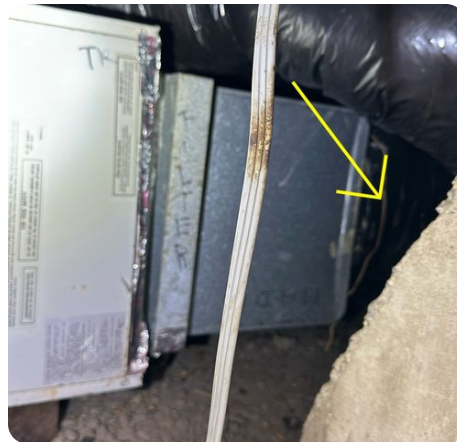
Location: North Side, Crawl Space

There was an obstructed access under a portions of the crawl, due to the furnace, heat ducts and low clearance. The inspector was only able to access beneath the primary suite area, and the furnace area. Future access would be needed to assess the condition of the crawl space and address any potential issues. Contact a qualified trade to access the remaining sub area when access can be gained.

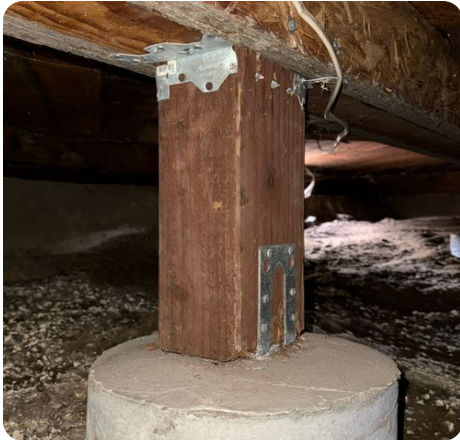
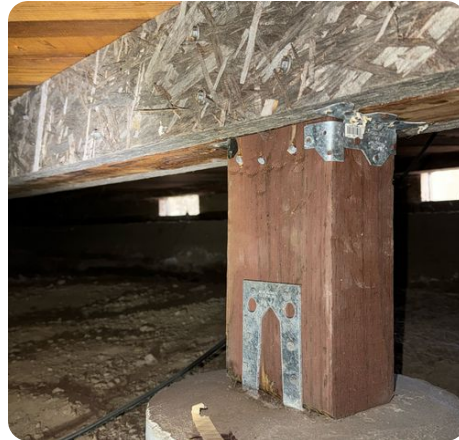
Location: Crawl Space

There were support posts and metal fasteners visible from underneath the home indicating past structural repairs. It is recommended to inquire with the seller for more information regarding the repairs that have been conducted in the past.

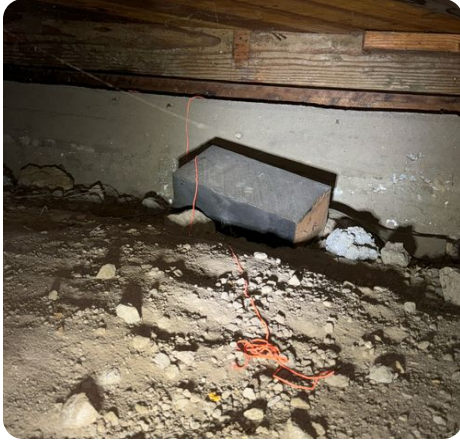
Debris and/or trash is present under the structure and should be removed. Avoid storing debris such as wood scraps, paper products, etc. in the crawl space to prevent attracting pests or creating health-related problems.
